## STAGE 1 & 2 ROAD SAFETY AUDIT REPORT FOR SITE H30, PERTH ROAD, STANLEY, PERTHSHIRE.

Report Ref 85820(1&2)

Issue Date 13-Feb-20

Site H30, Perth Road, Stanley, Perthshire.  
Road Safety Audit Stage 1&2

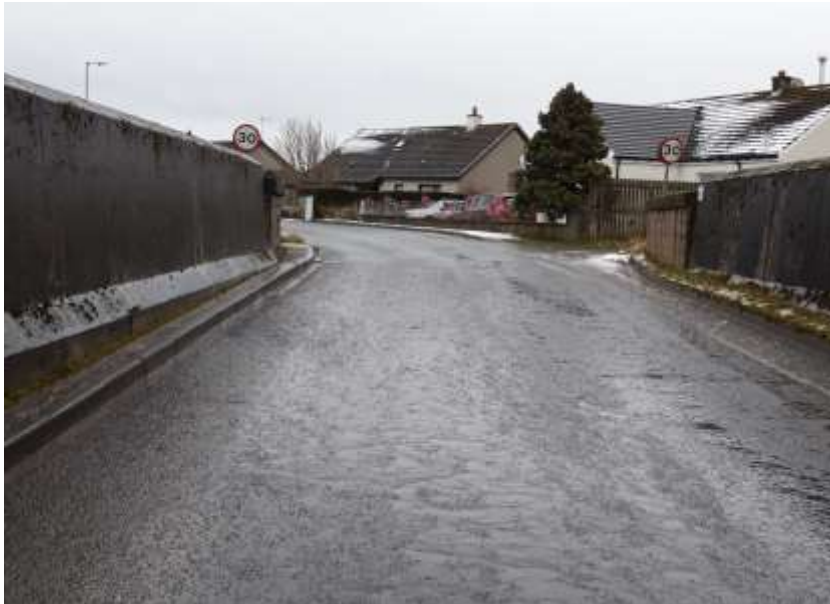
Location Duchess Street.

Summary Risk of pedestrian injury collisions.

Sightlines between eastbound approaching drivers and pedestrians at the uncontrolled crossing point are restricted by the concrete parapets of the adjacent railway bridge. The eastbound approach road alignment towards the bridge has a tight right hand bend which limits approaching speeds. Drivers however may not see, nor expect, pedestrians waiting to cross the road immediately on the west side of the bridge. This could result in a pedestrian stepping out into the path of an eastbound vehicle, resulting in a serious injury collision.

1. The drop kerbs and tactile paving on the north kerblines are positioned to optimise sightlines between pedestrians and eastbound drivers.
2. A danger ahead warning sign (Diag 562) with a "Pedestrians Crossing" sub-plate is provided on the eastbound approach to the crossing point.

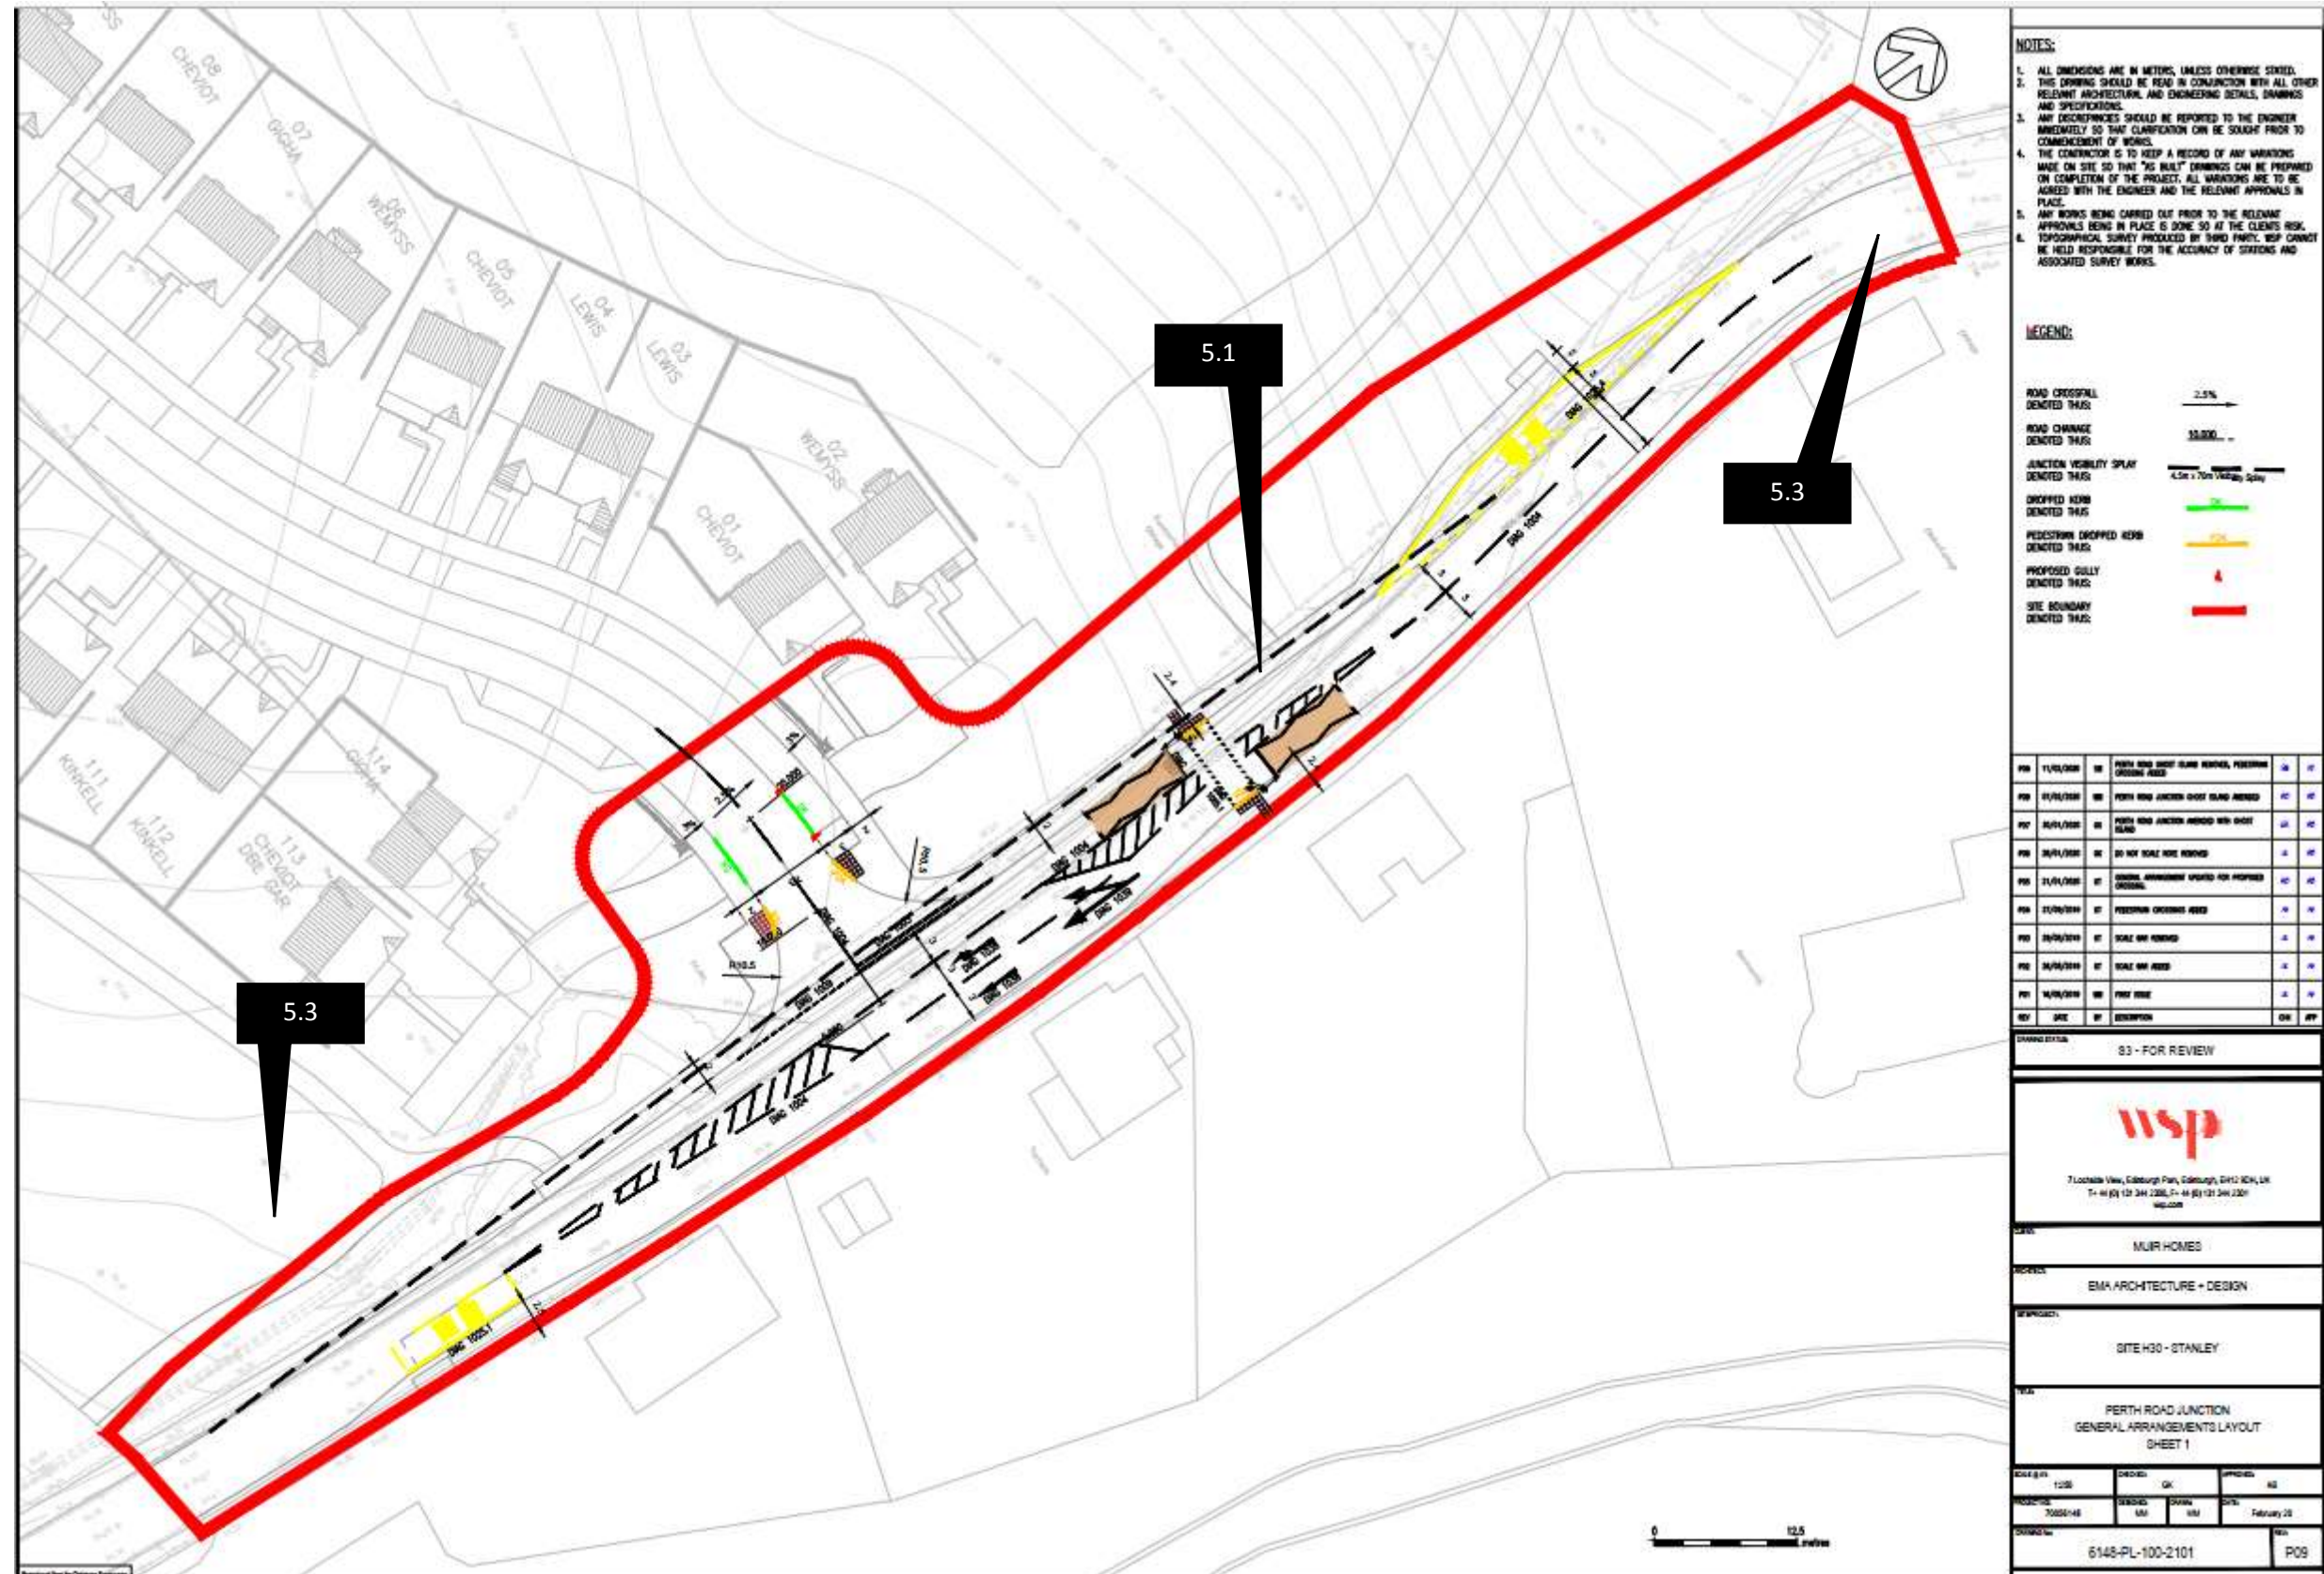
Perth Road, Stanley.

Location B9099, Perth Road.

Summary Risk of aquaplaning type collisions.

The carriageway is to be widened on its west side and a footway added. This will give a greater surface area to be drained. When heading north the road profile falls away from the new junction towards a tight right hand bend. The additional carriageway width could result in additional surface water crossing the carriageway towards the road gullies at the bend. During periods of heavy rainfall this could result in excessive surface water crossing the carriageway which may contribute to aquaplaning type collisions.

Summary Risk of vehicle striking turning traffic or pedestrians.

A new junction and altered alignment will generate new turning manoeuvres that some drivers may not expect to encounter. There is a risk that approaching drivers who are not aware of the new junction or road alignment will not adjust their speed accordingly and this could lead to a loss of control type collision.

It is recommended that the additional carriageway width and footways are drained towards the development and not across the carriageway in advance of the bend.

It is recommended that temporary New Road Layout Ahead signs (Diag 7014)<sup>2</sup> are provided on both approaches.

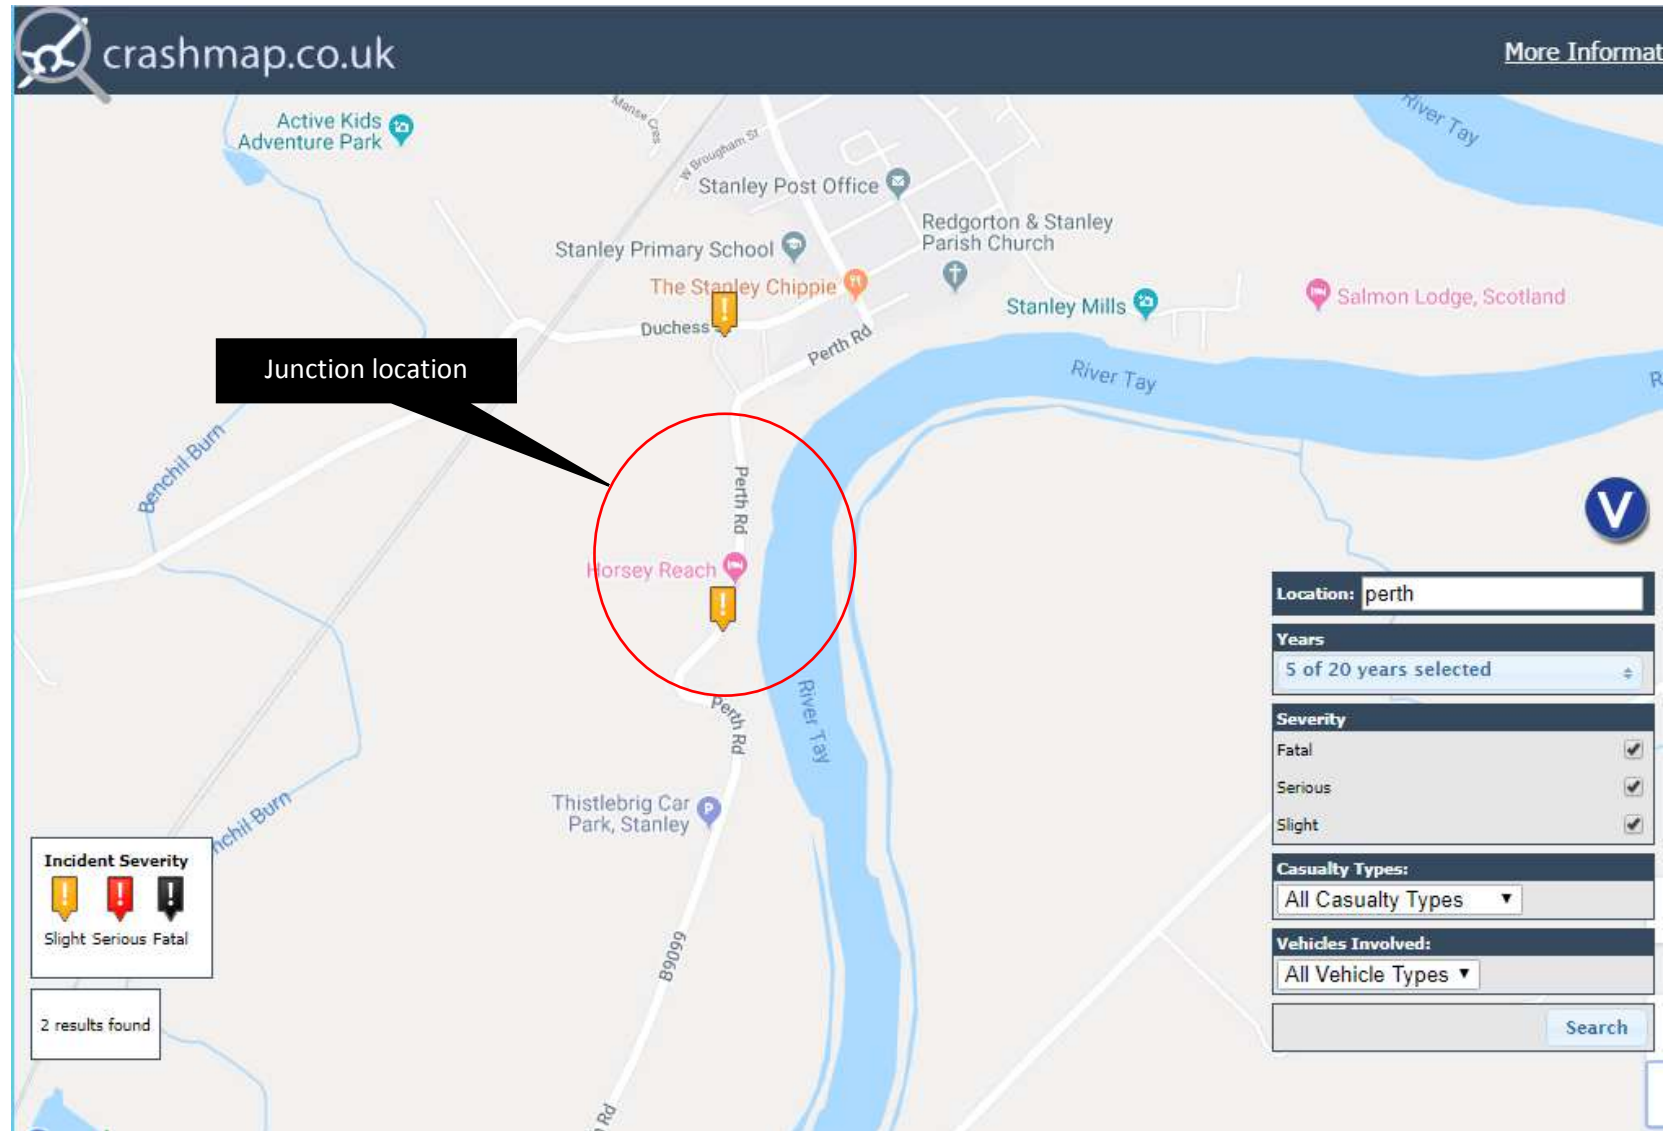
Appendix B. Location of Recorded Collisions.

2.3. Road traffic collision information has also been retrieved from [Crashmap.co.uk](https://crashmap.co.uk) . See appendix B. This shows one collision near the proposed junction during the 5 year period 2014-18. This took place at 2:00pm on Friday 17<sup>th</sup> January 2017 as a consequence of a single vehicle losing control during frost or icy conditions. It resulted in a slight injury to the car driver.
