PERTH AND KINROSS COUNCIL**Environment Committee****12 November 2014****Blairgowrie, Oakbank Road Landslip****Report by the Executive Director (Environment)****PURPOSE OF REPORT**

Landslip Options Report

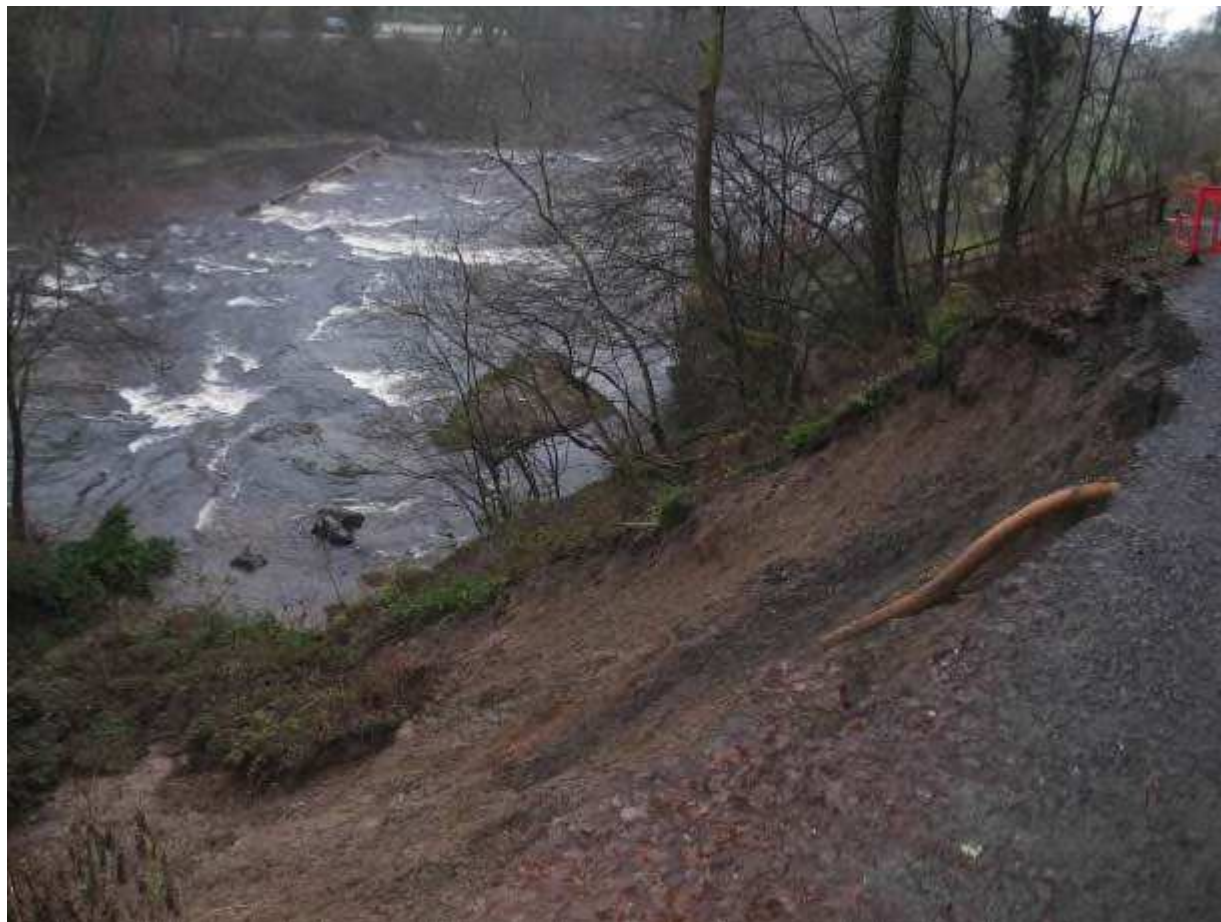
2012 Landslip Damage

- 1.2 A severe landslip occurred on the Oakbank Road just prior to Christmas 2012 following a period of sustained heavy rain. This saturated the embankment material and increased the river flow causing erosion to the base and subsequent collapse. A section of the track up to 1.3m wide was lost over a length of approximately 19m to a width of about 30m. An estimated 600 tonnes of material was washed down the river (Appendix 2). The edge of the track continues to erode. There has been previous movement of the slope on a 12 metre long section with partial failure of a retaining wall in 2011, further north of the 2012 landslip. There is evidence the whole area has been subject to several slippages in the past.

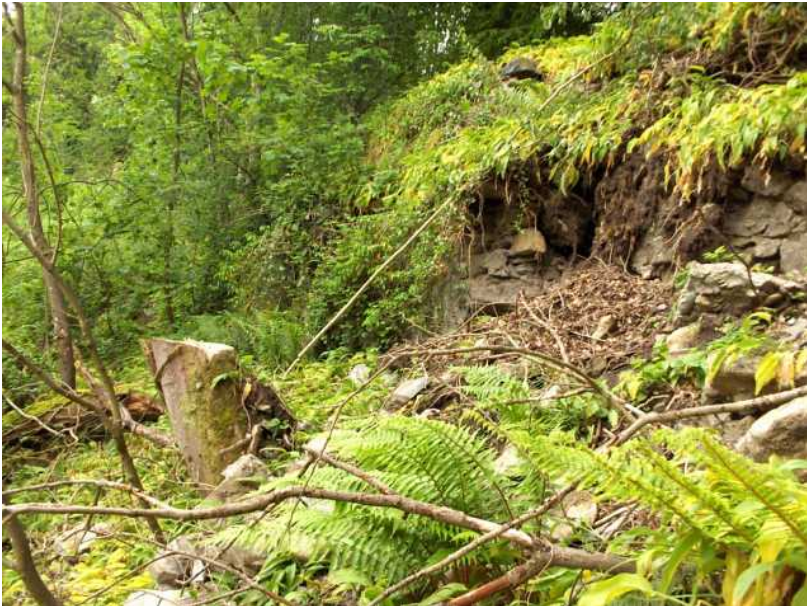
- **2011 Landslip** "The resulting slope face is currently at 1 in 1.5 (35°) and is likely to have only marginal stability and be susceptible to soil creep...A section of wall remains but it is likely to tumble at some point." p2-1

*Plate I - The 2011 Landslip – note masonry blocks tumbled down slope
 (Photo dated 12 Jun 12)*

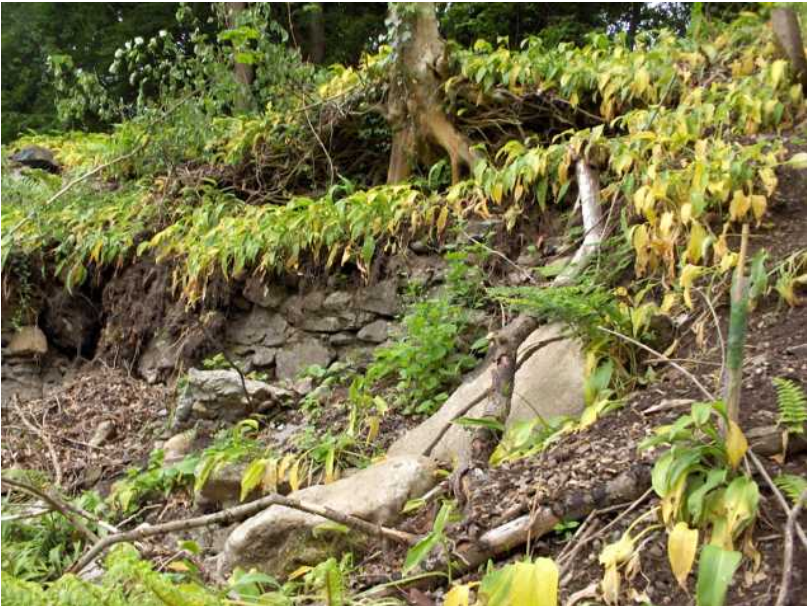
*Plate II - The 2011 Landslip – intact section of wall
 (Photo dated 12 Jun 12)*

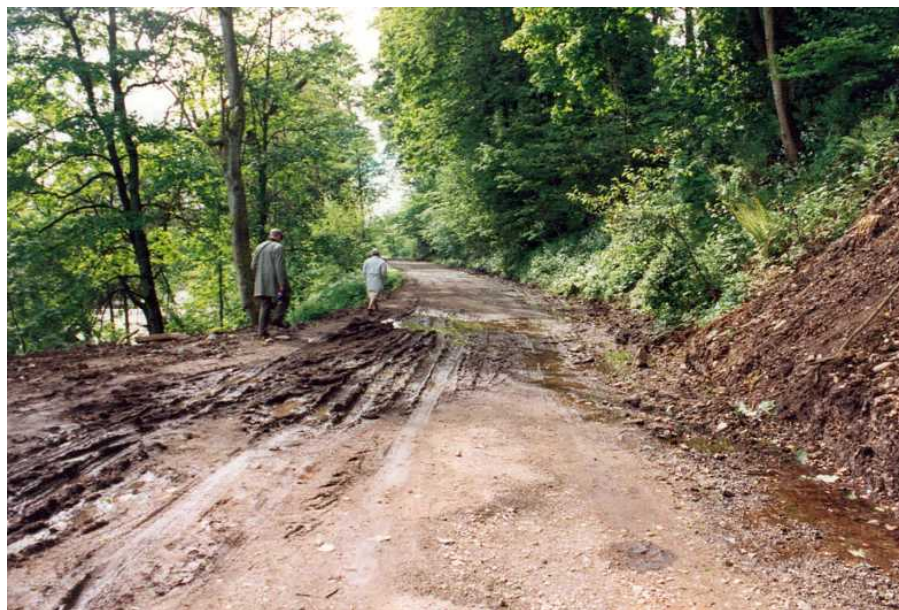
*Plate III - View North towards the 2011 Landslip
(Photo dated 12 Jun 12)*

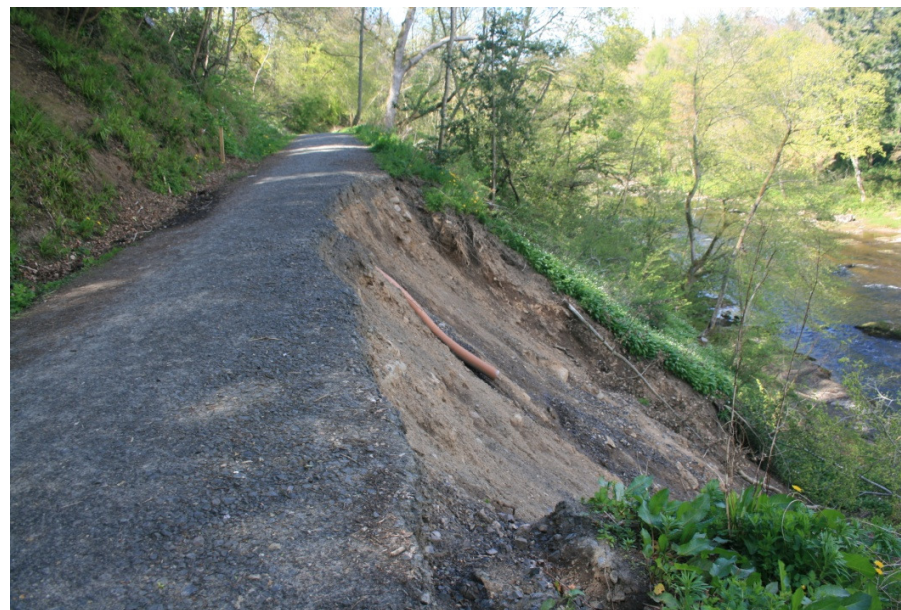
- **2012 Landslip** "The exposed soil face along the north edge of the landslide is ...an over-steepened lower slope where river erosion and landslide has removed the toe of slope. This would be a key preparatory factor in the landslide incident that was observed in December 2012, this in combination with wetting up of the materials in a period of heavy rainfall." p2-2

'A severe landslide occurred in December 2012 following a sustained period of heavy rain. At the failed section the slope height is typically 10.5m. The toe of the slope is retained by a stone wall which varies in height from 1.0-3.5m. The width of the failed section was measured as 19m at the top of slope and 20m at the foot of the slope. The depth of the failure is typically 1m. Upon visual inspection the slope appeared to

*Plate IV - View North over the 2012 Landslip
(Photo dated Dec 12)*

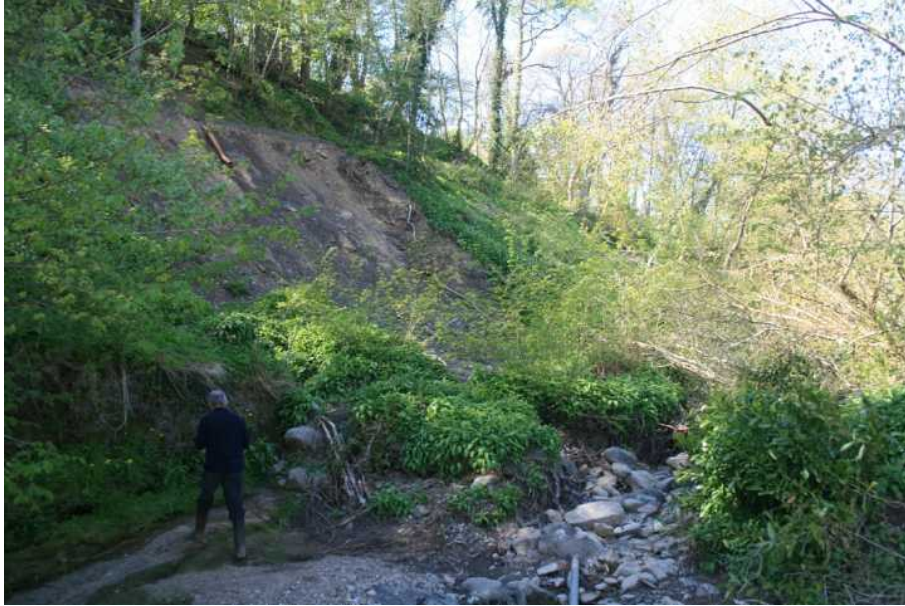
*Plate V - View from the river up to the 2012 Landslip
(Photo dated Dec 12)*

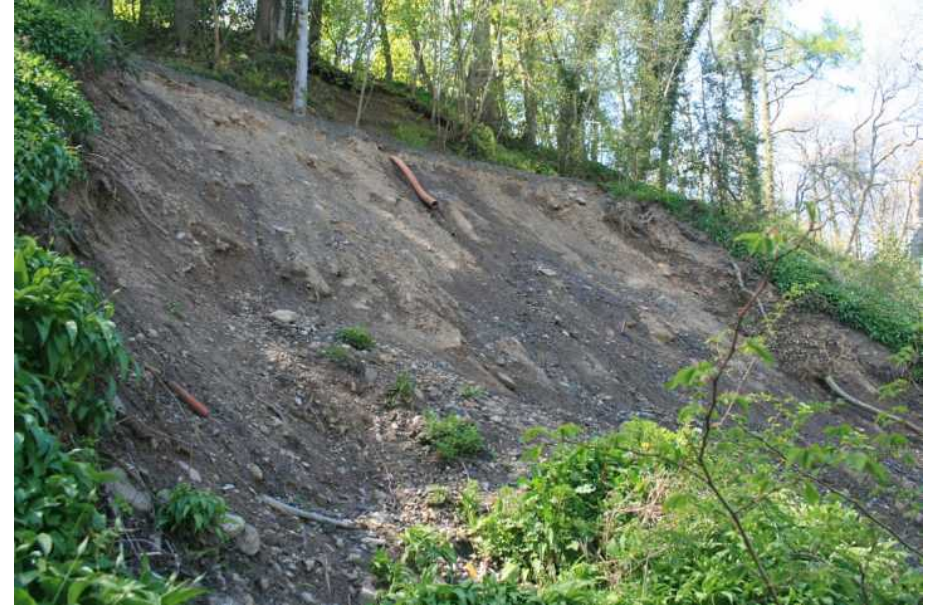
This is a shallow translational failure with some characteristics of debris flow that has spilled a slab of soil off the slope face and into the river. Coincidentally there is a scar in the slope above the road directly behind this landslip (see Plate VI). Consideration has been given to this being part of a more deep seated landslip with the observed failure being a secondary collapse of an over-steepened toe. However, the absence of lateral tears across the road to connect the two areas suggests that these features are unrelated. The depth of observed landslip is self evident as the steepness of the slope has resulted in the 'slip bowl' being fully evacuated to expose in-situ material. The exposed face is approaching 1 in 1 (42°) in the upper slope and 1 in 2 (27°) in the lower slope.

*Plate VI - View up to the 2012 Landslip – note scar in slope above the road
(Photo dated Dec 12)*

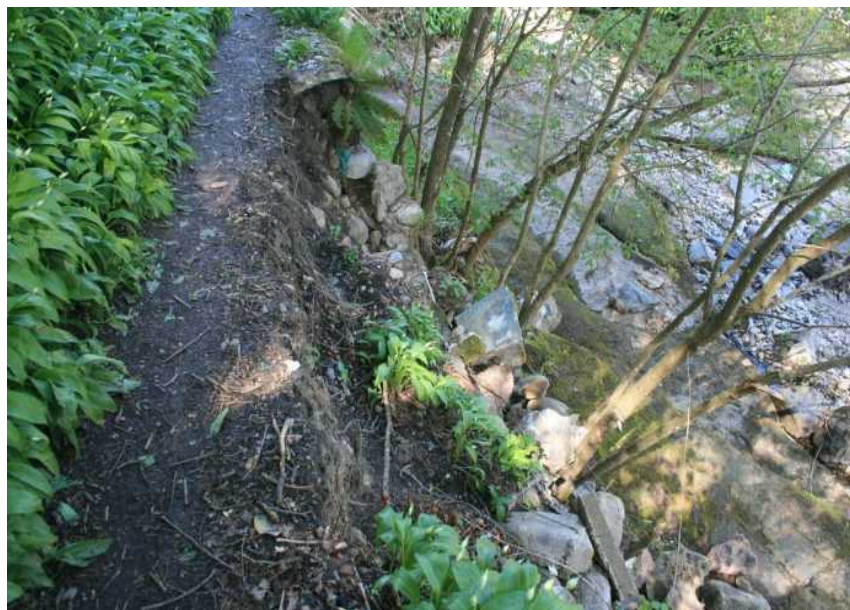
In addition to the above, we understand that a wall some 15m south of the 2012 landslip collapsed at around the same time (see Plate VII). This is some 1.5m in height and carries a narrow footpath below a wooded area and alongside the river bank. It is believed to have been constructed around the same time as the weir/ sluice/ mill lade structures. It may be that the landslide impacted directly on the wall further along, which caused vibration and collapse of this vulnerable section of masonry, but other than that the two incidents appear to be unrelated.

*Plate VII - Wall collapse in the vicinity of the 2012 Landslip
(Photo dated Dec 12)*

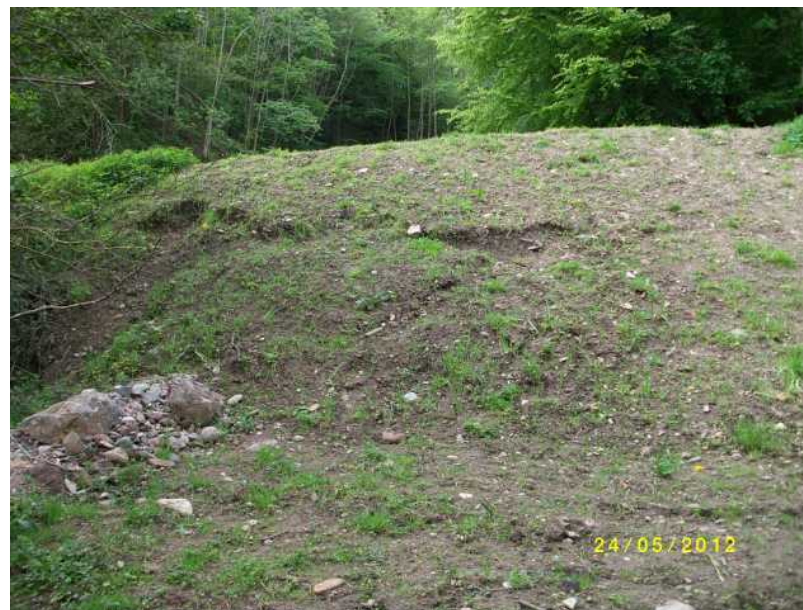
Plate VIII

- Road embankment containing Cuttle Burn Culvert that collapsed when the culvert blocked and water over-topped the embankment. This got remediated prior to 2011 (Plate VIII).
- Road embankment above the grassed amenity area, identified as Area 3 in 'Brief for WP H118 – Blairgowrie Riverside'. Proposals have been made for remediating this section of embankment.
