**Proposed Stanley Community Hub, Perth Road, Stanley
For Stanley Development Trust**

**Preliminary Ecological Appraisal
Phase 1 Habitat, Protected Species Survey and
Ecological Impact Assessment**

Wednesday 31st May 2023

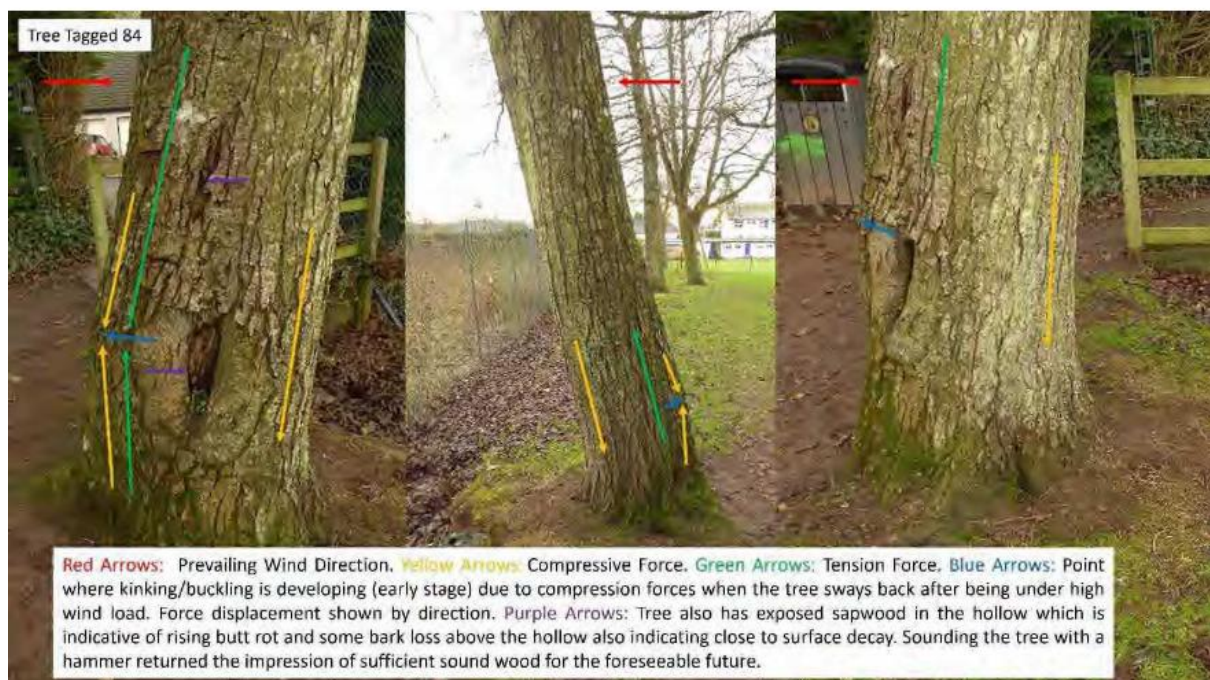
The tree tagged 84, figure 7.1, has lower trunk decay and the initial signs of buckling in its lower western aspect. This should be monitored by re-inspection every 1.5 years. The tree tagged 86 has a similar though lesser buckling issue. Both trees would benefit from minimal weight reduction on their eastern aspect that is not crown lifting. See section 10.

Figure 7.1: Tree 84. Early buckling signs to west aspect at 0.5m. Caused by a combination of lower trunk decay and the return sway (mass damping) of the tree once released from wind load.

If the tree tagged 84 is retained, then it would benefit from re-inspection every 1.5 years regarding the signs of buckling and its basal decay. All other trees should be inspected every five years. Sooner if there has been a significant storm.

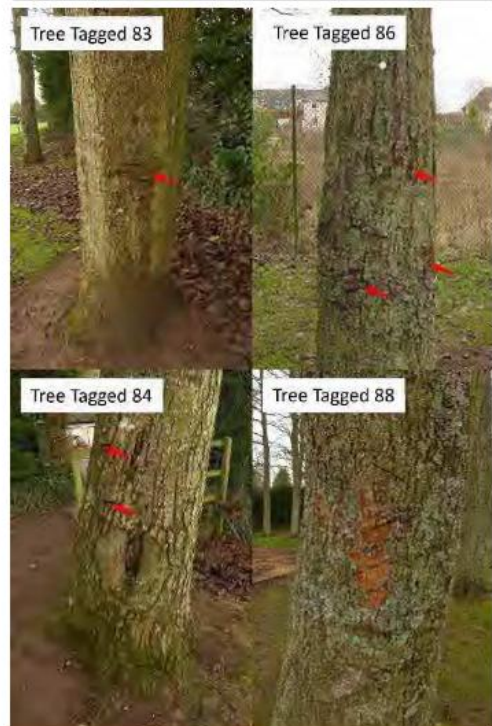
Figure 7.3: Trees 83, 84, 86 & 88. Vandalism with an axe.

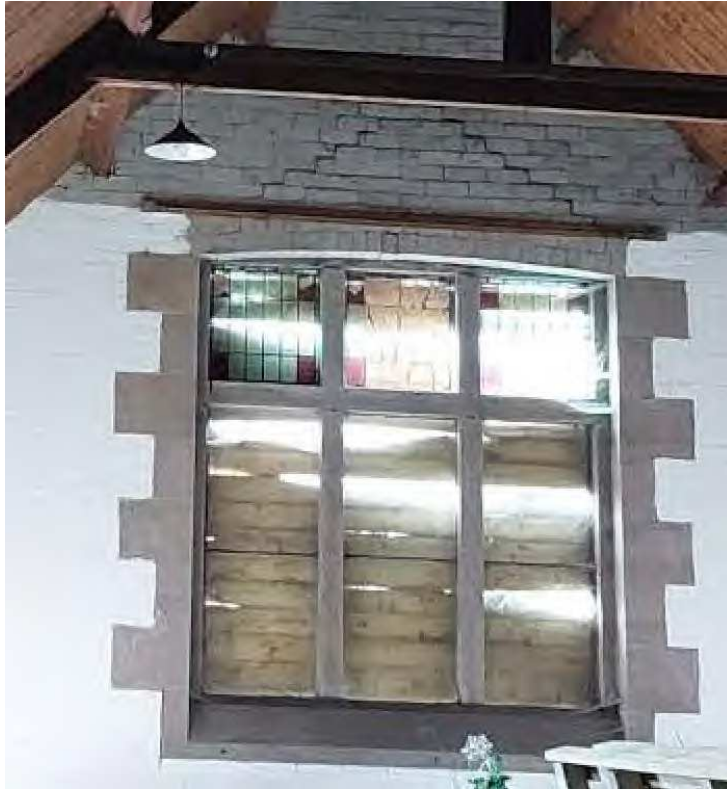
Finally, there are fairly large V-shaped cracks which have formed to each side of the window openings in the masonry walls. These cracks indicate that the external walls have differentially settled due to the increased loading caused by the window openings. This settlement has caused some unloading of certain areas of the masonry and lateral movements to occur around the windows meaning that the bricks have slid laterally as well as forming cracks vertically. It is possible that the nearby foliage has caused subsidence locally also as there are some small trees nearby and the underlying ground is expected to contain shrinkable clays. It is likely that the movement to the walls could be the trigger for the splaying of the roof and the two effects are compounding the movements seen.

Figure 5: Example of Inverted V Shaped Cracks over Windows

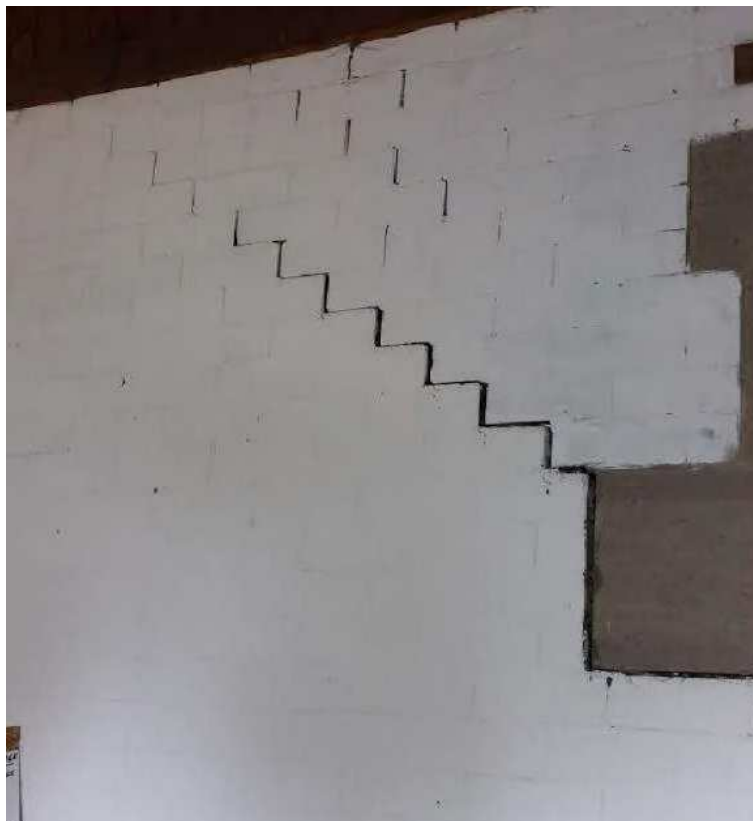
Figure 6: Example of Cracking from Excessive Settlement in External Walls

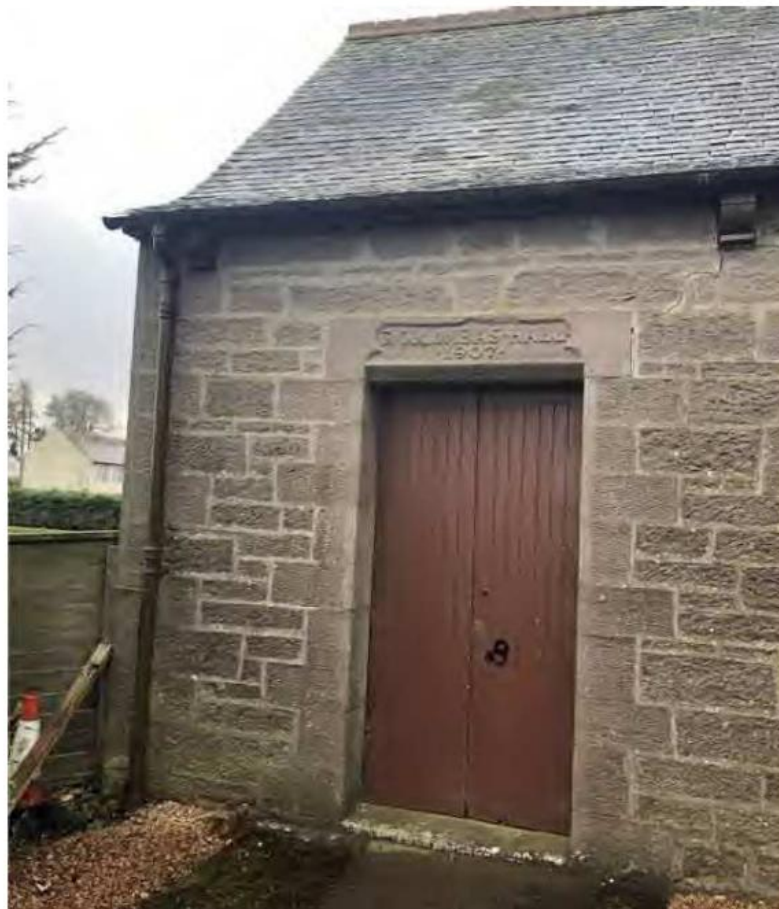
- 3.8 The church hall is of limited architectural interest, containing few architectural details and surviving in poor disused condition. As such it is concluded that the hall does not contribute to the special interest of the adjacent church, which is of special interest as a good example of a late 19th century partly prefabricated church building designed for the Episcopal Church, which has undergone limited alterations, and remains in use as a church.

Figure 3.3: Church hall south-east entrance with 1907 date stone lintel
