| <b>TCP/11/16(581) – 18/01400/FLL – Alterations to roof at<br/>Wester Parkhead House, Parkhead Road, Blairgowrie</b> |

**TCP/11/16(581) – 18/01400/FLL – Alterations to roof at  
Wester Parkhead House, Parkhead Road, Blairgowrie**

# Re-roofing of Wester Parkhead Farmhouse, Blairgowrie

## Planning Supporting Statement

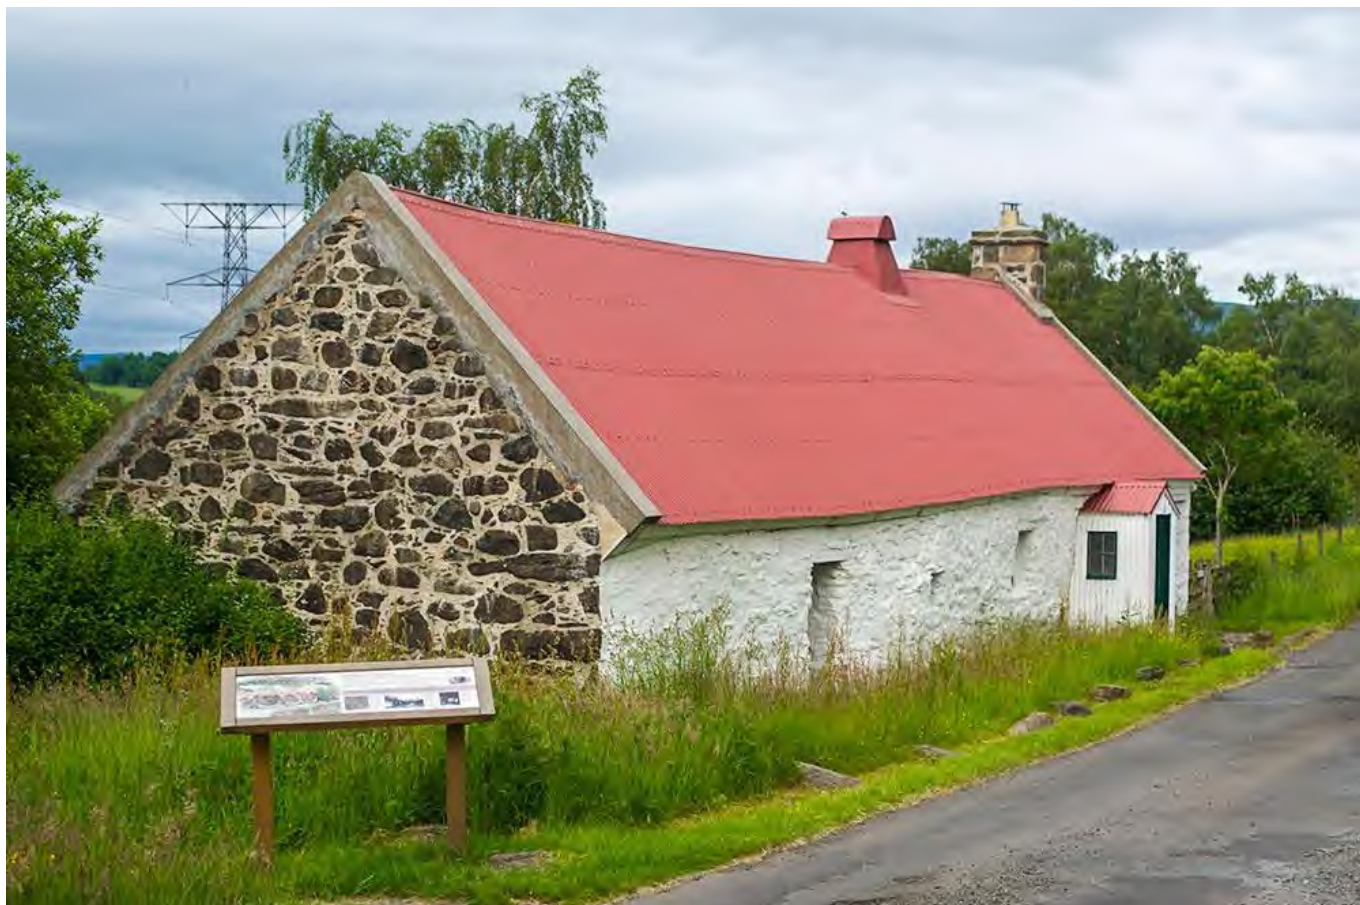
Moirlanich Longhouse, Stirling. (This longhouse is owned by National Trust for Scotland and features a sheeted roof). The NTS website describes this as a “Beautifully conserved cottage giving unique insight into rural family life in 19th -century Scotland”.

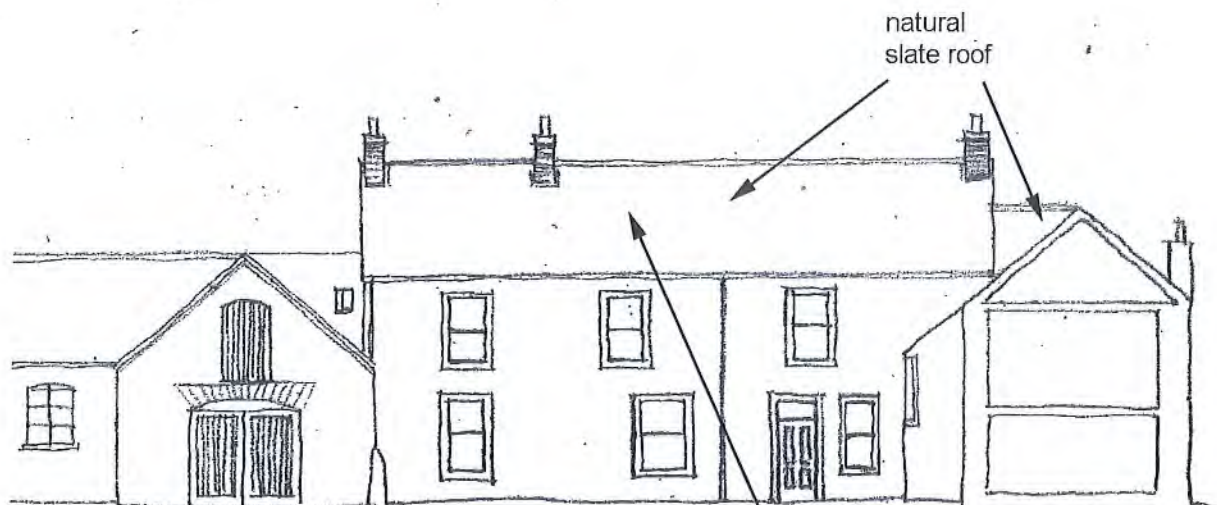
West elevation of East wing

bats roosting  
in this roof void

It should be noted that the roof plan submitted indicates the entire roof structure is to be overclad with corrugated sheeting, however, the elevational drawing for the west elevation of the east wing indicates this to be natural slate. I sought clarification from the agent, however, at the time of writing this report no communication had been received. For the purposes of assessing the proposal, it is assumed the entire roof structure is to be overclad.

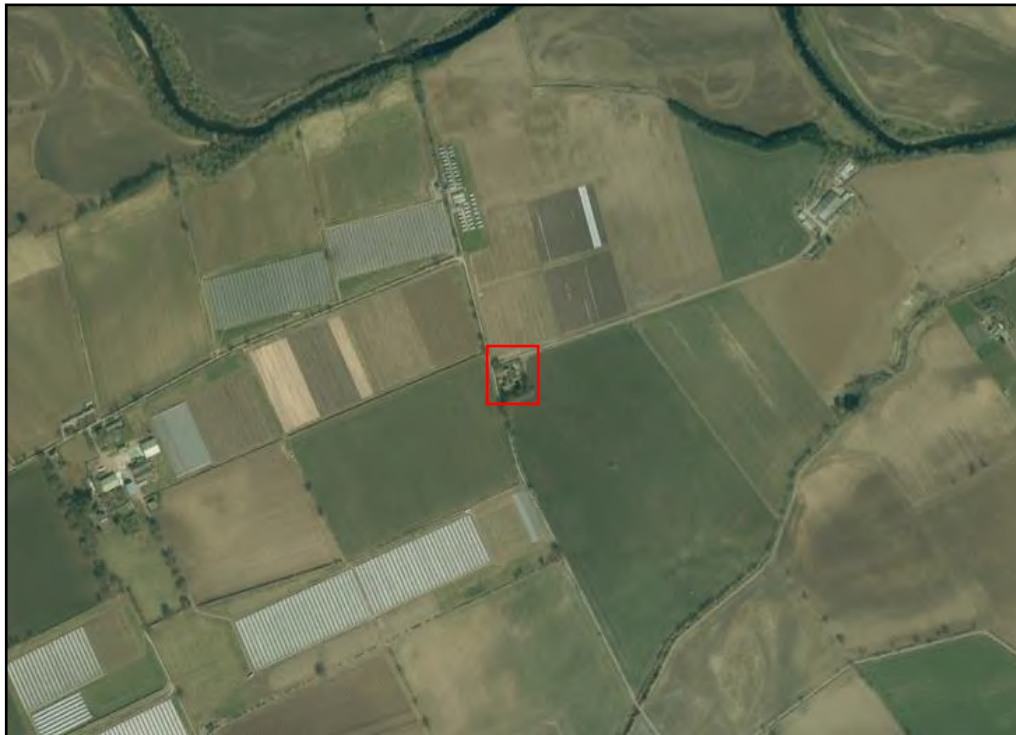
Figure 1. Aerial photograph of Wester Parkhead Farm and wider environs. The site is outlined in red and shown in more detail in Figure 2.

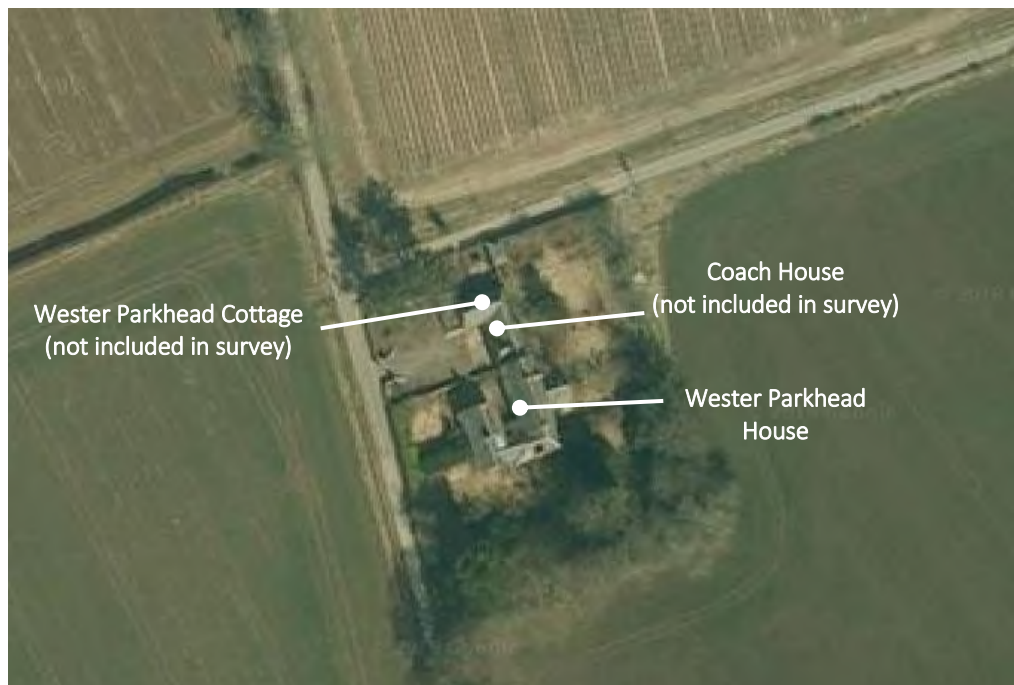
Figure 2. Aerial photograph of Wester Parkhead Farm. The proposed works will involve the replacement of the roof coverings of Wester Parkhead House, all other buildings within the farm will be retained unmodified.

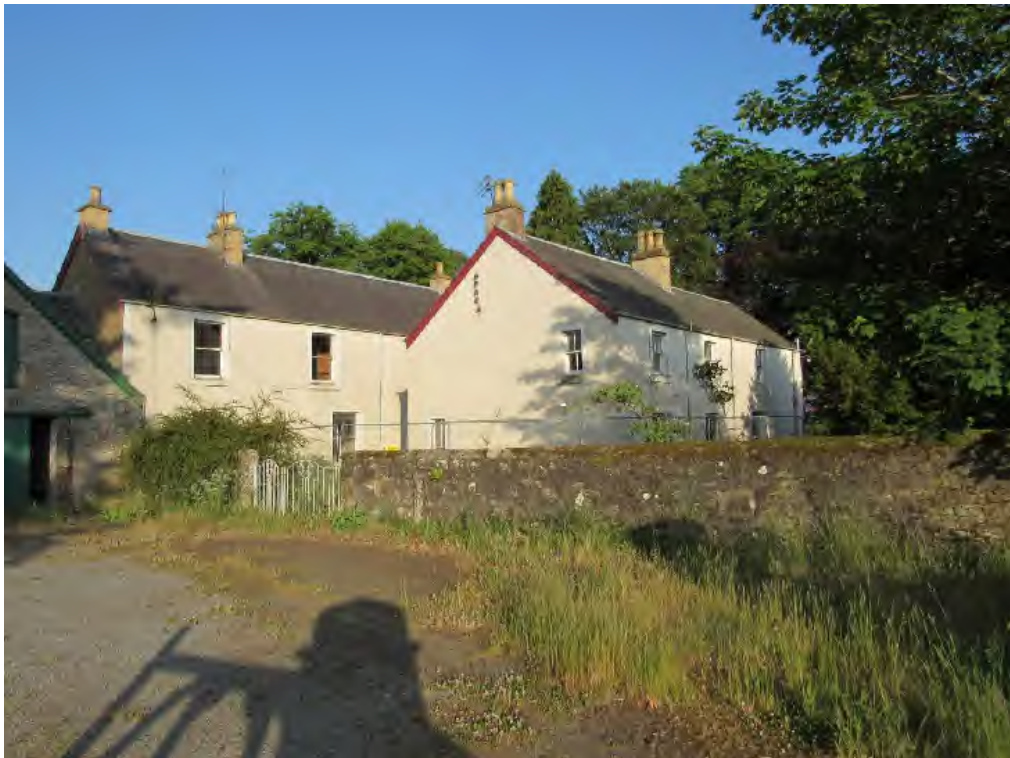
Figure 4. Wester Parkhead House – northwest elevation.

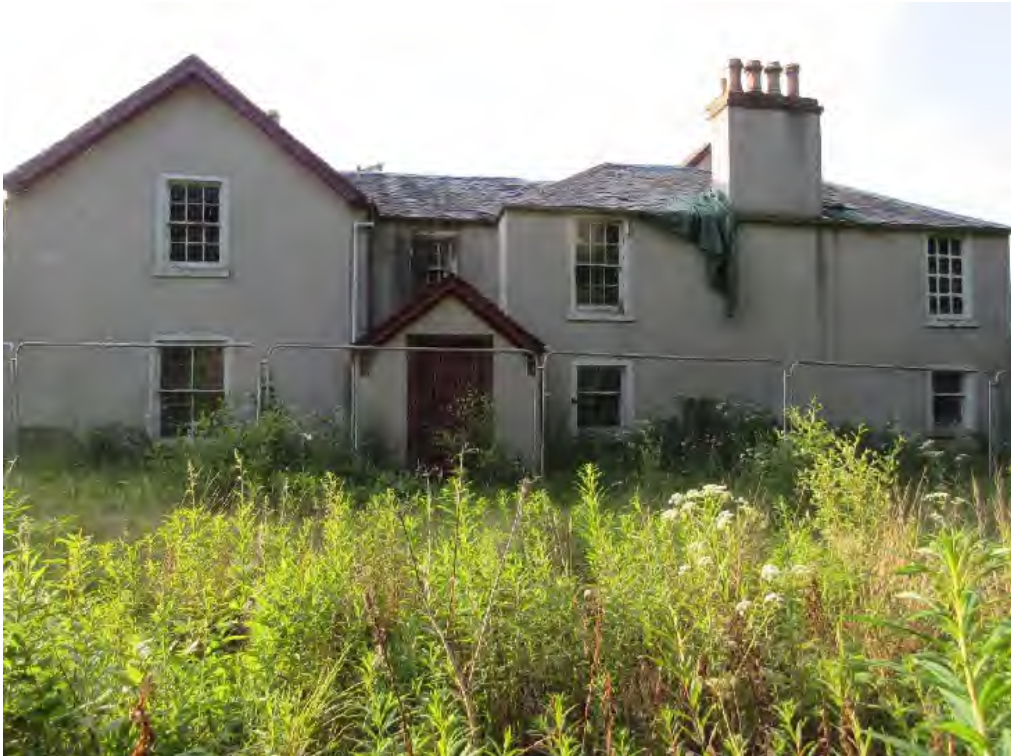
Figure 5. Wester Parkhead House – southern elevation.

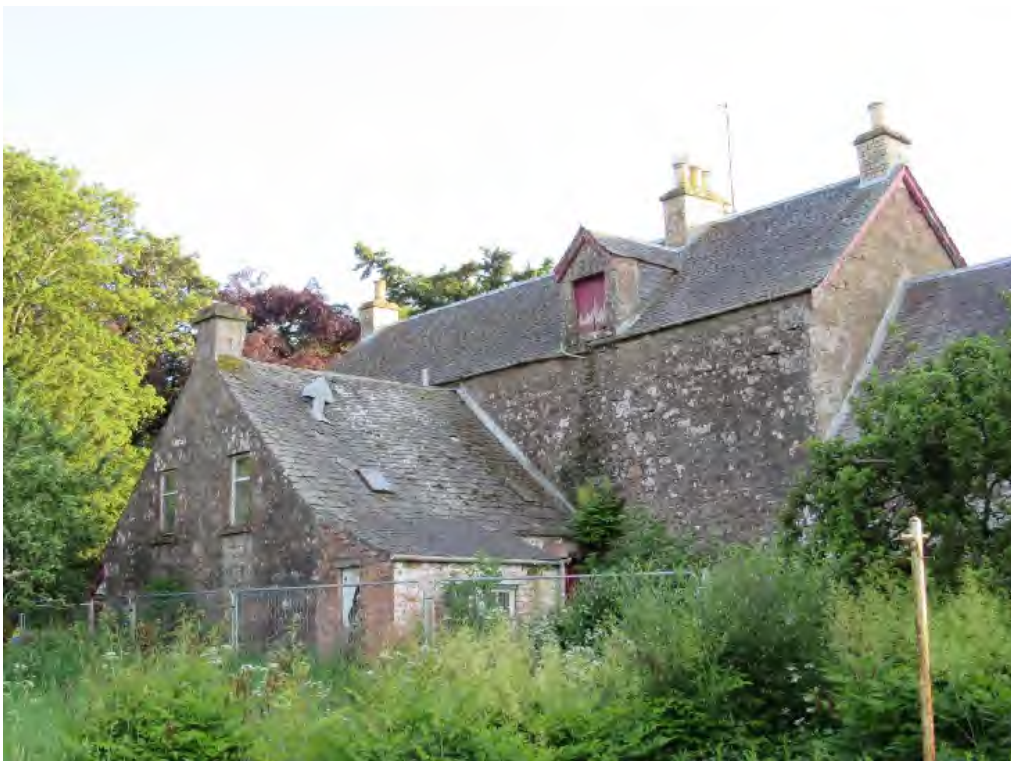
Figure 6. Wester Parkhead House – eastern elevation.

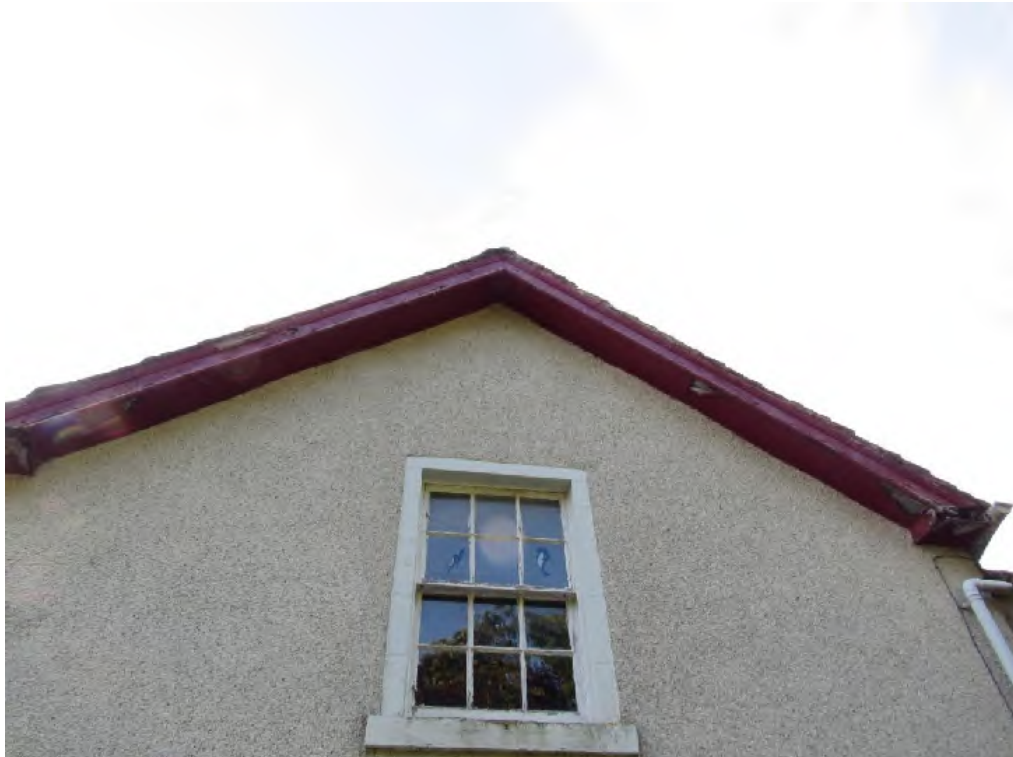
Figure 7. The majority of the external render is in good condition, and tightly sealed with no potential roost sites for bat species.

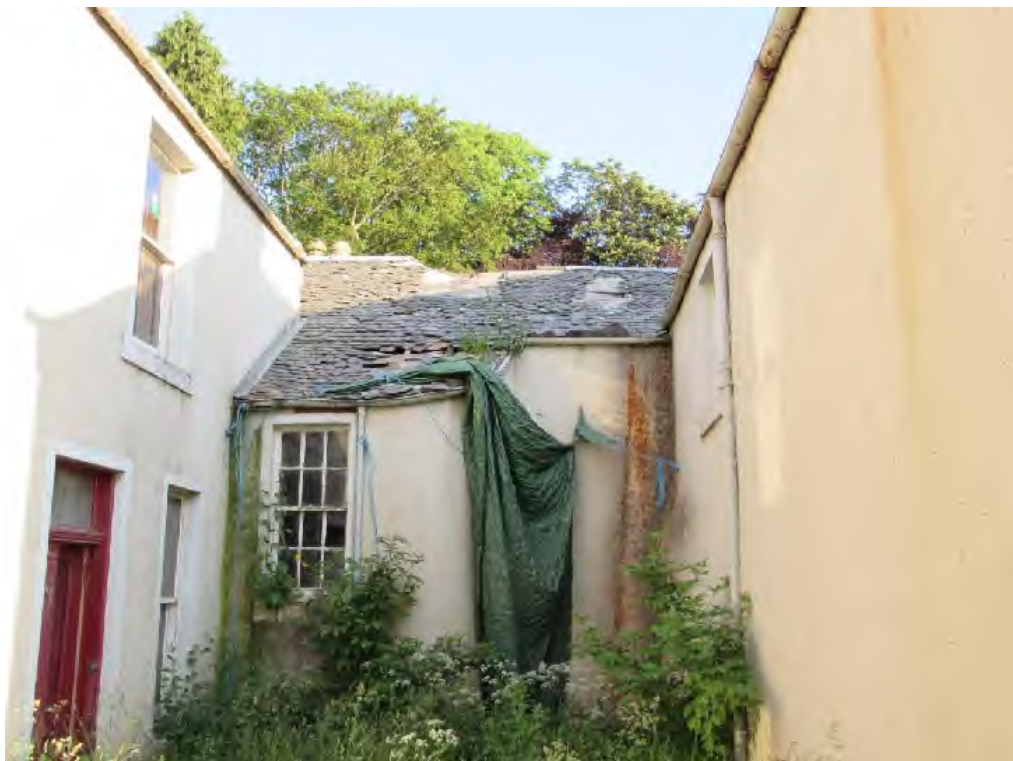
Figure 8. Some sections of the roof are in poor condition and continued water ingress has left the roof timbers badly rotted and in a state of partial collapse.

are in extremely poor condition and in a state of partial collapse (**Figure 8**). As would be expected for a rural building of this age there are numerous locations across the external fabric of the building that could be exploited by roosting bats:

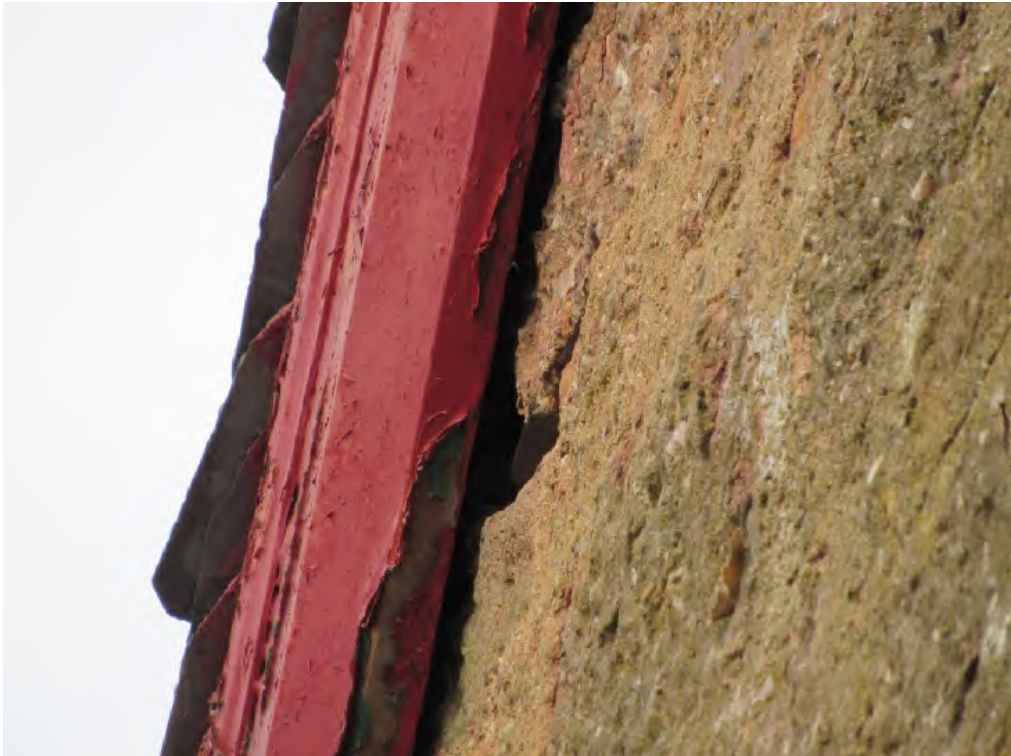
Figure 9. Washed out mortar beneath the bargeboard on the northern elevation provides a potential access point to the roof void.

- Washed out mortar beneath the bargeboard on some of the gables (Figure 9).
- Numerous raised and missing slates (**Figure 10**).
- Large sections of missing slates which have resulted in significant damage to the underlying sarking leaving large holes providing direct access to the building interior (**Figure 11**).
- Large gaps beneath the flashing along the ridge (**Figure 12**).

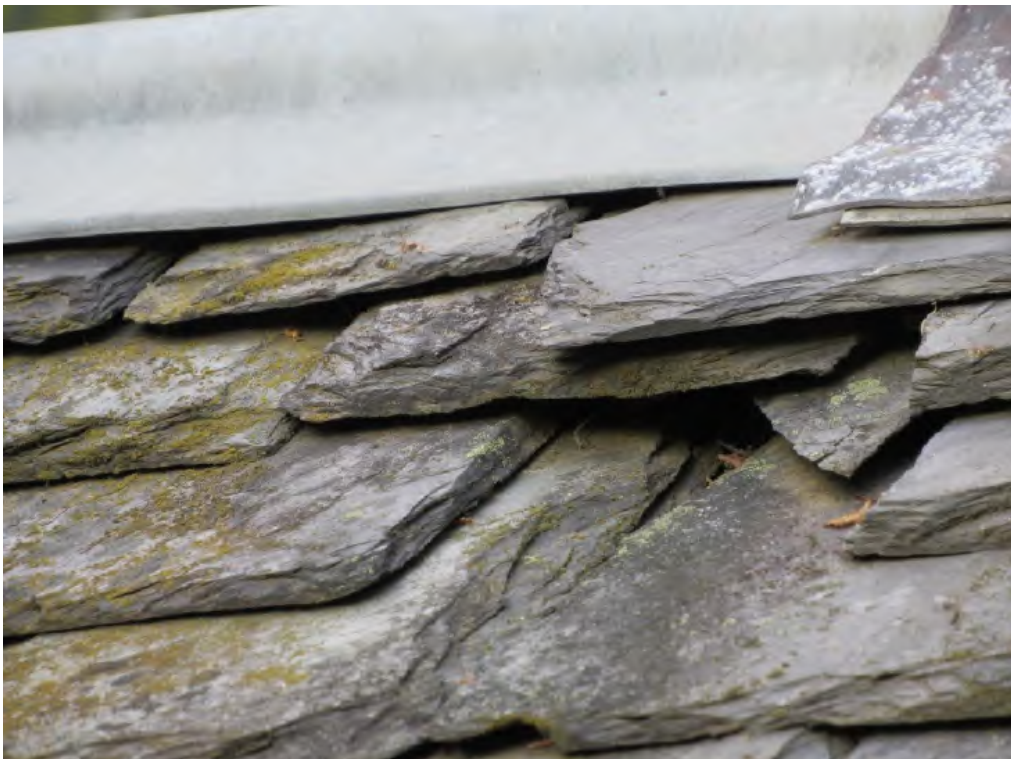
Figure 10. Gaps beneath slates provide access to spaces between slates and sarking – a common roost sites for crevice dwelling bat species.

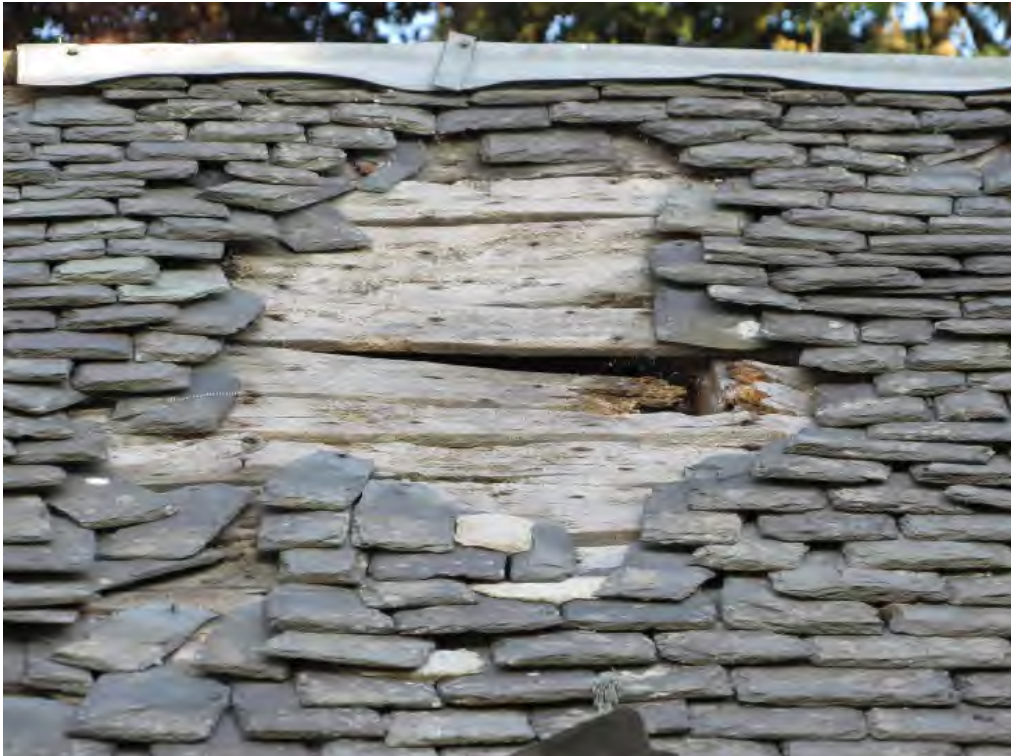
Figure 11. Some sections of the roof are in poor condition and continued water ingress has left the roof timbers badly rotted and in a state of partial collapse.

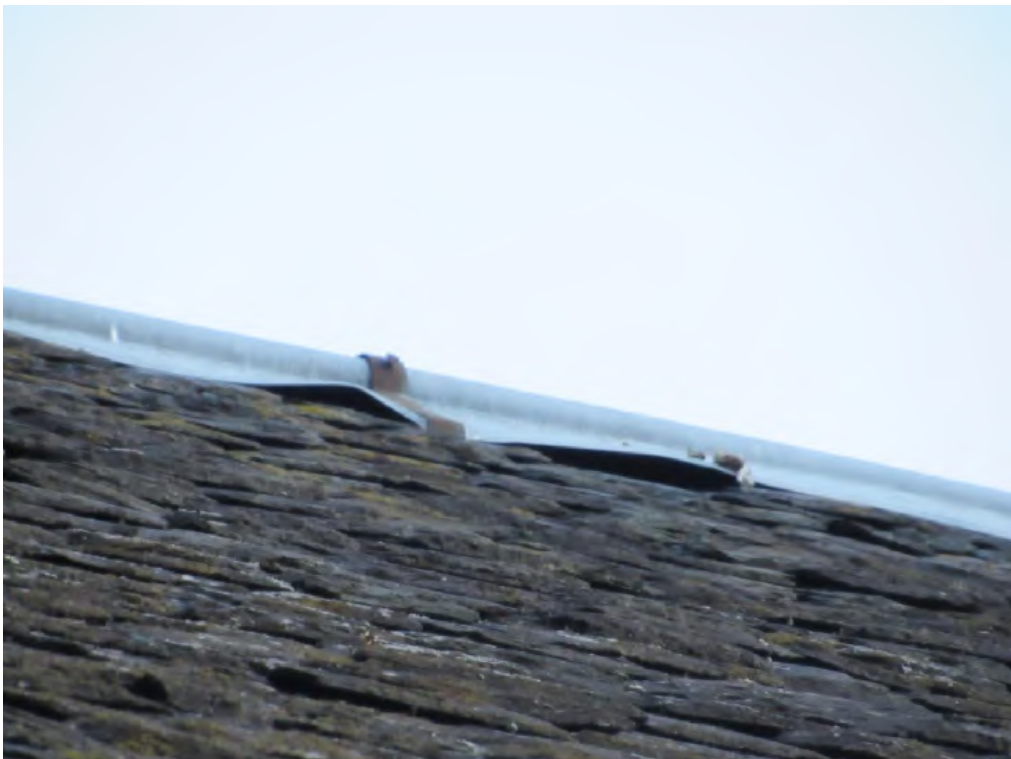
Figure 12. The void beneath ridge flashing is a common roost site for pipistrelle species.

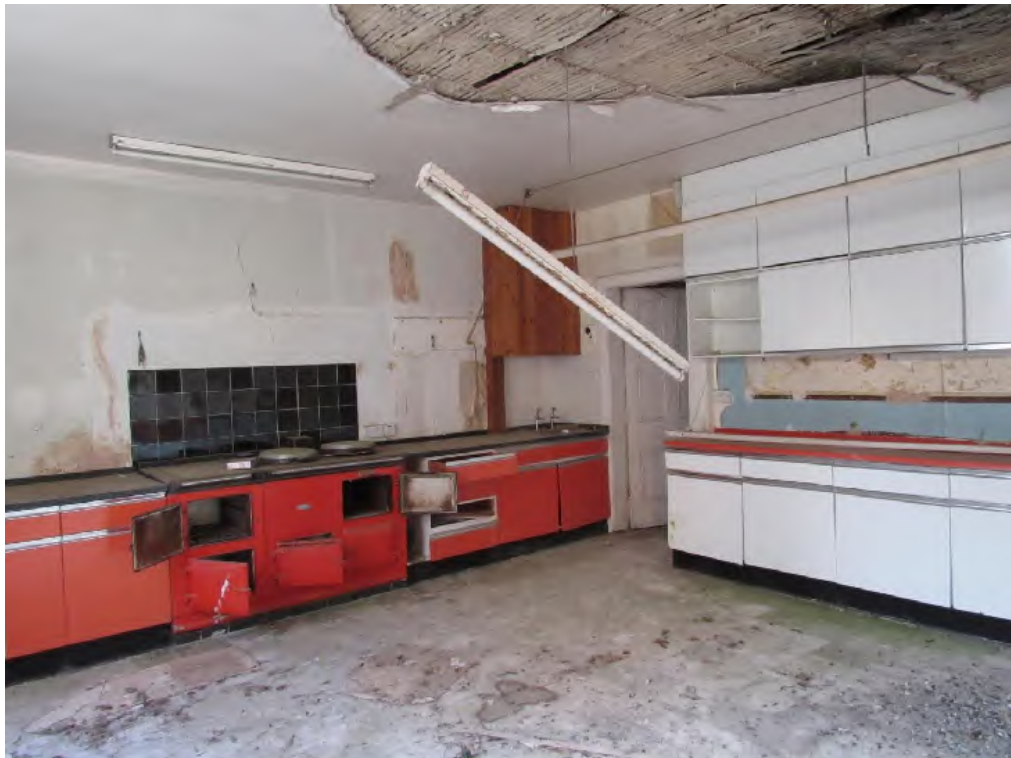
4.4. The ground and first floor of the property comprise typical residential accommodation and no features were identified that would provide potential roost sites for bats (**Figure 13**). However, the complicated roof structure of Wester Parkhead House includes a variety of roof voids beneath the pitched and hipped roofs. To facilitate interpretation of the results all roof voids have been labelled A - D in **Figure 3**. All efforts were made to access the roof voids; however, in some cases (roof void labelled C) the poor condition of the roof void made access impossible due to health and safety concerns.

Figure 13. The ground and first floor of the house is in poor condition but does not provide potential roost sites for bat species.

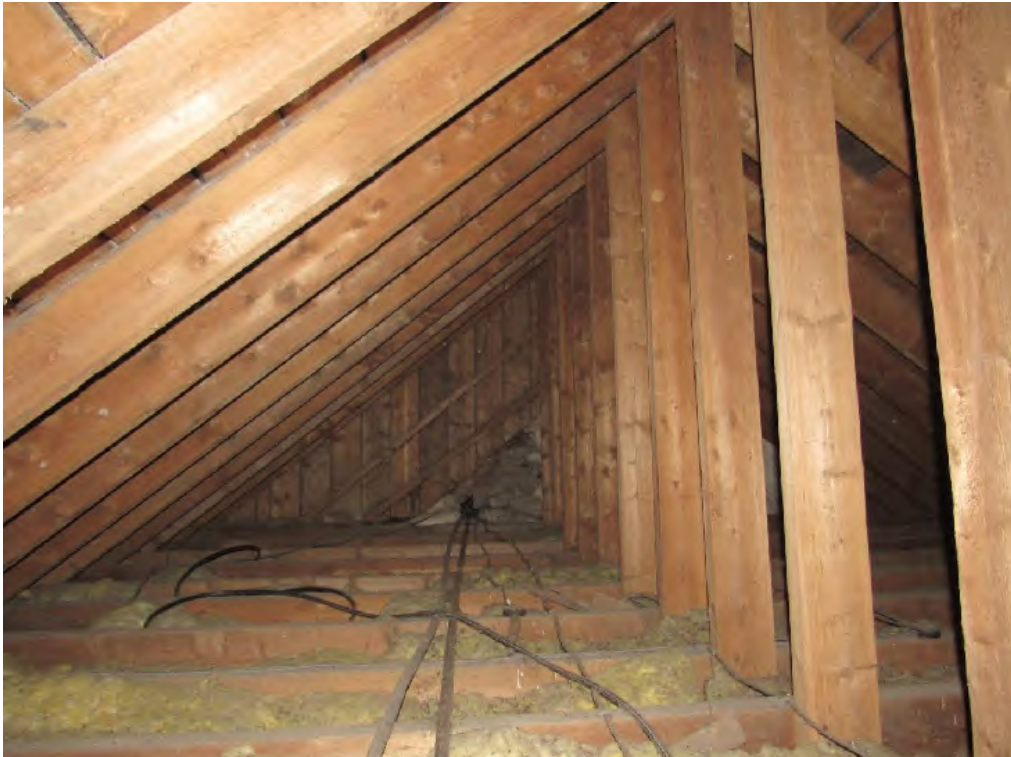
4.5. This is a small square roof void bisected by a number of vertical supporting struts (**Figure 14**). The roof void has an apex height of approximately 1.5m and is lined with wooden sarking throughout. Despite a thorough inspection there was no evidence to indicate that bats have ever been present within this area.

Figure 14. Roof void labelled A in Figure 3.

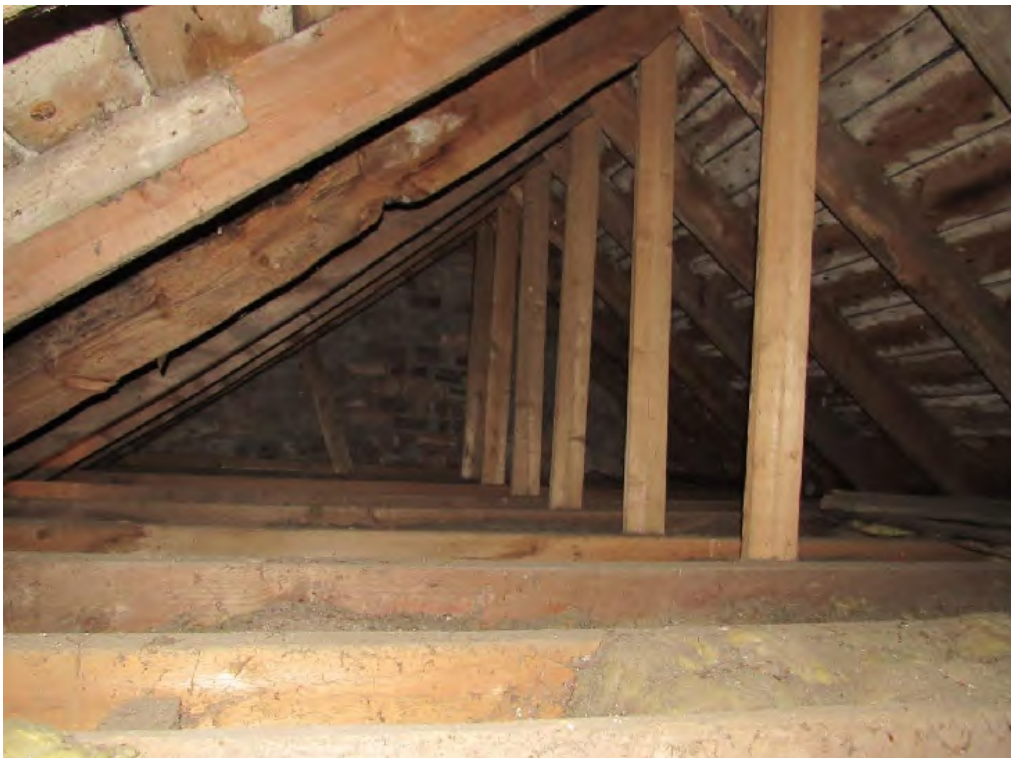
4.6. This is a small square roof void bisected by a number of vertical supporting struts (**Figure 15**). The roof void has an apex height of approximately 1.5m and is lined with wooden sarking throughout. However, continued water ingress has left the majority of the sarking and joists badly rotted and despite a thorough inspection there was no evidence to indicate that bats have ever been present within this area.

Figure 15. Roof void labelled B in Figure 3.

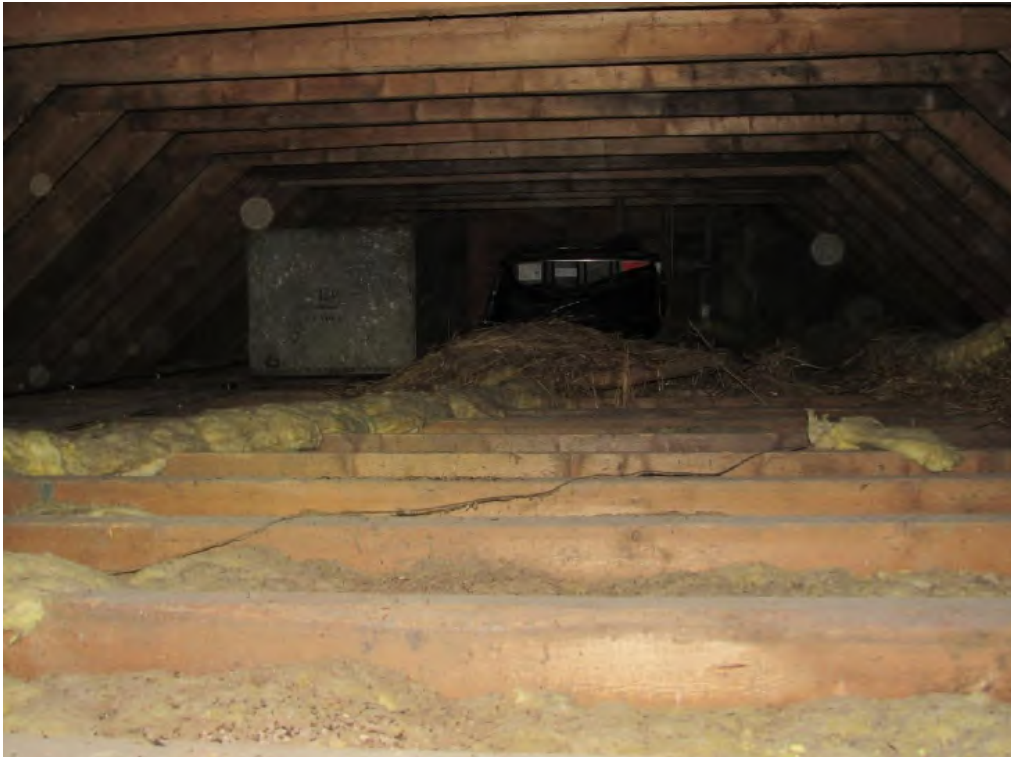
4.8. This is a long, linear roof void (apex height approximately 2m), collar beamed and lined with wooden sarking throughout (**Figure 16**). Immediately upon entering the roof void it was clear that bats were present, there was a distinct 'batty' odour and droppings were liberally scattered atop the insulation beneath the central ridge (**Figure 17**). The shiny and granulated appearance of the droppings clearly identified them as brown long eared droppings and although hundreds of droppings were present the vast majority were old and discoloured (>1yr old) and only an estimated 40-50 fresh droppings were identified.

Figure 16. Roof void labelled D in Figure 3.

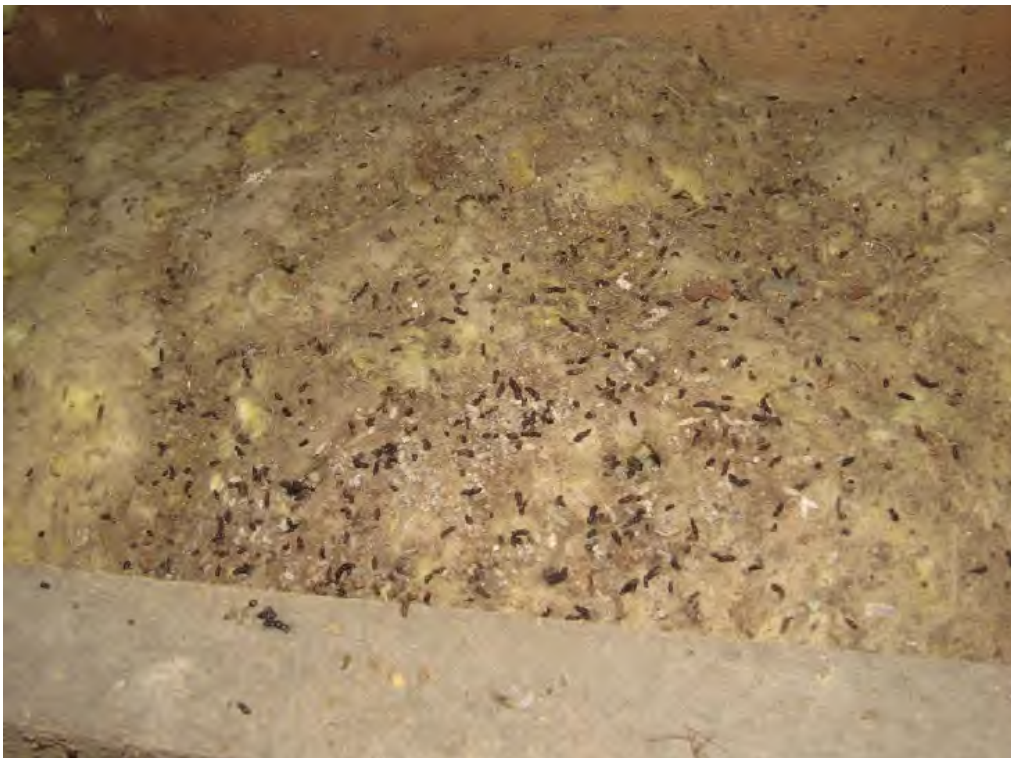
Figure 17. Brown long eared droppings identified within roof void D.

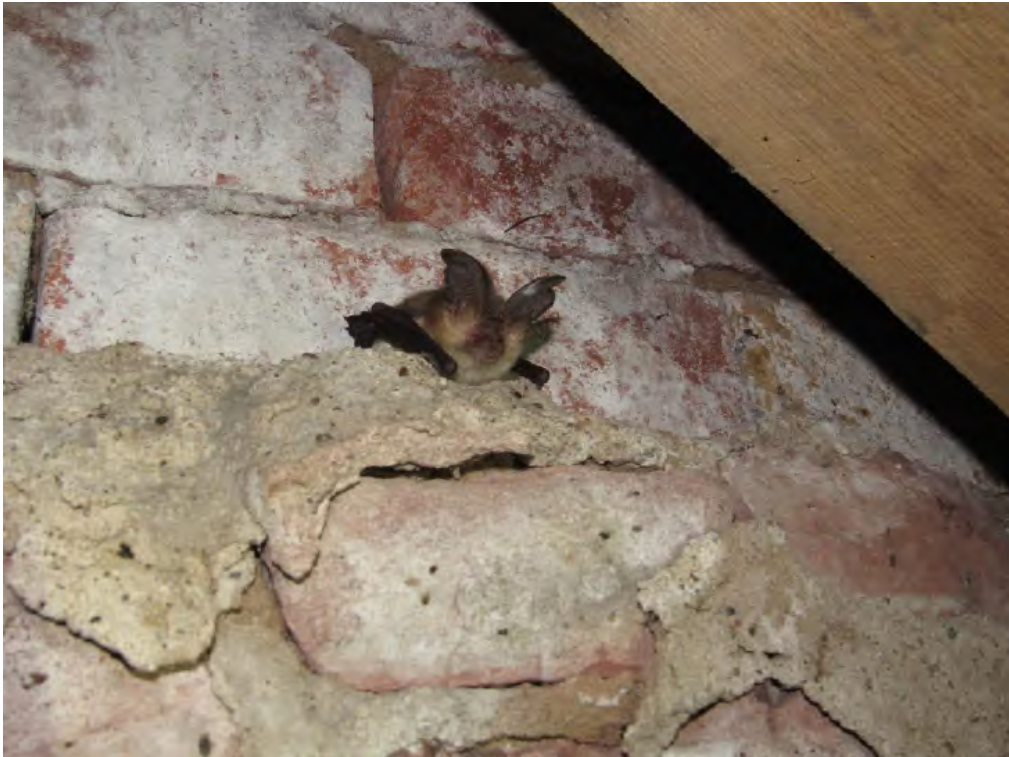
Figure 18. Brown long eared bat perching on the stonework on the southern gable end of the roof void. Droppings can be seen adhered to the stonework in this location and a potential exit point was identified above this location, see figure 19.

4.9. A total of six brown long eared bats were subsequently found roosting in individual locations within the roof void within the roof void (see **Figure 18**). All bats were carefully

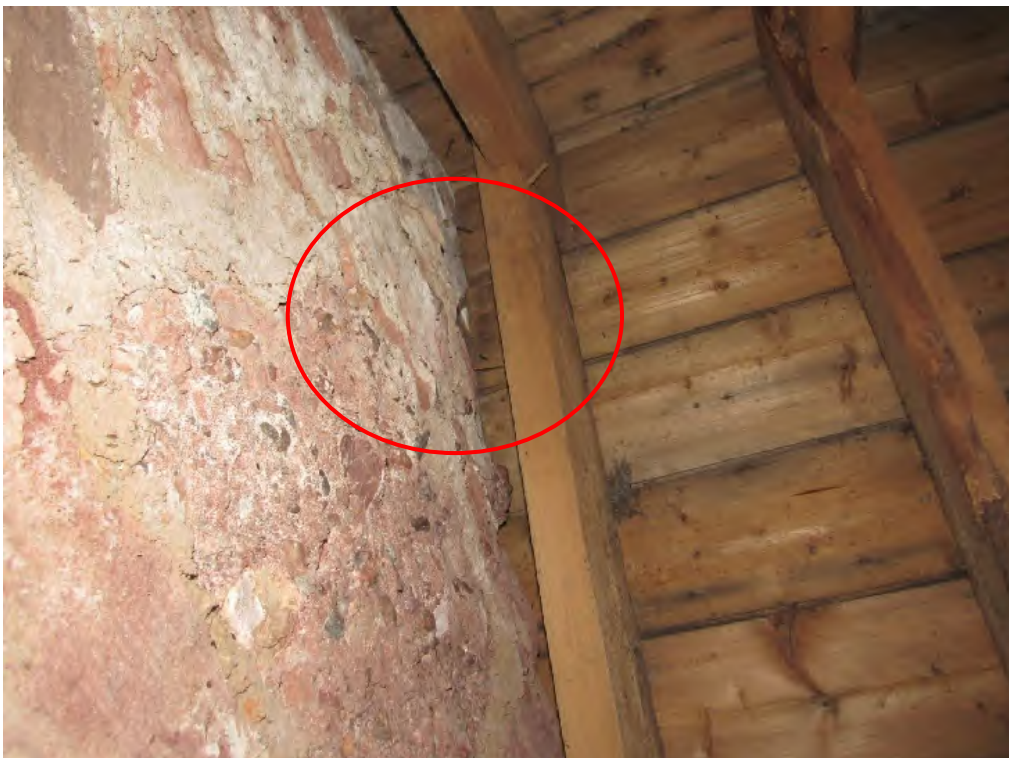
Figure 19. A large gap along the wallhead leads directly to a gap in the external render on the southern elevation of the house, see figures 20 & 21.

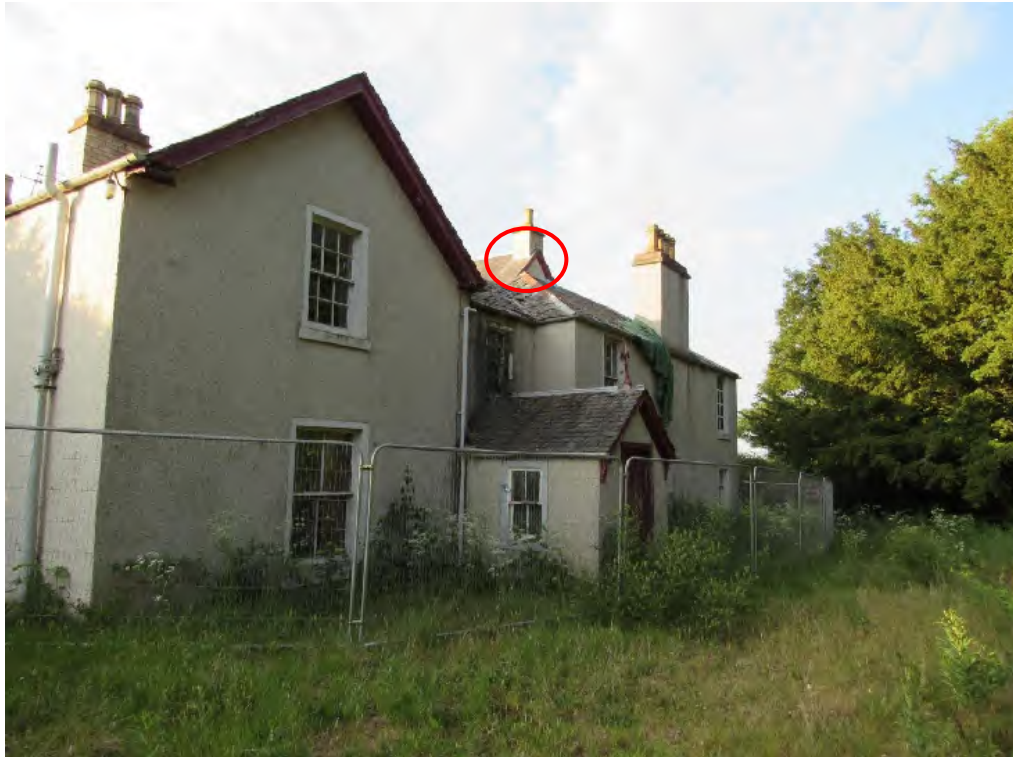
Figure 20. Exit point for brown long eared bats roosting within roof void D, shown in more detail in Figure 21.

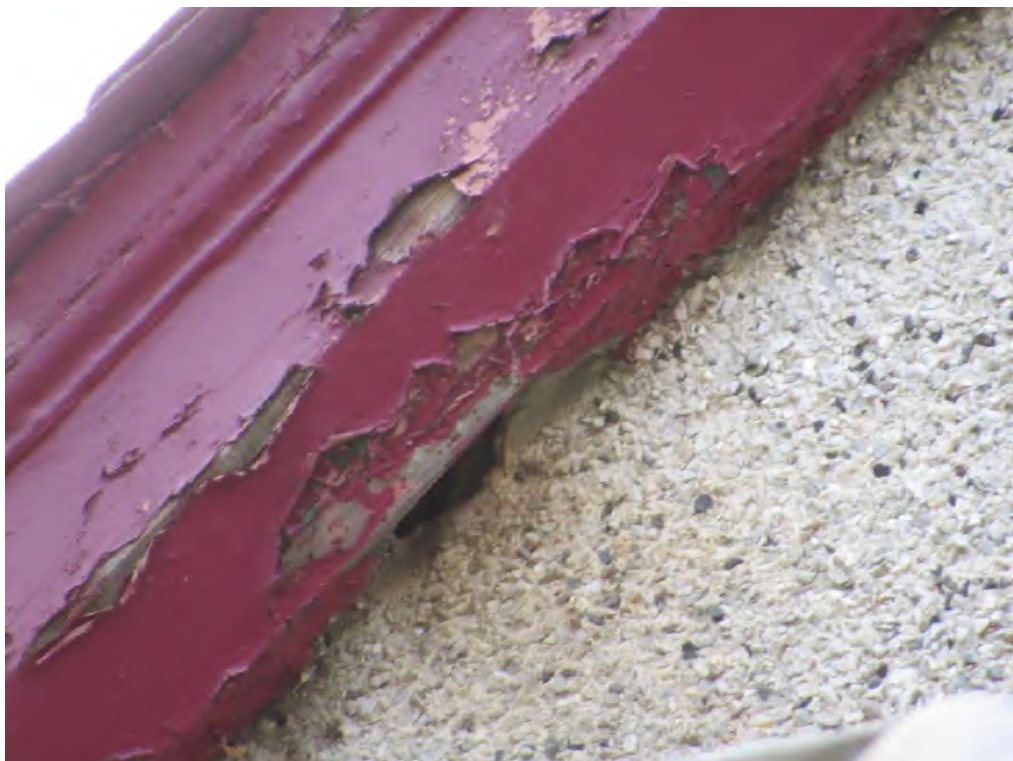
Figure 21. This small section of washed out mortar leads directly to the gap above the wallhead in roof void D (see figure 18 & 19) the render beneath this location is clearly stained.

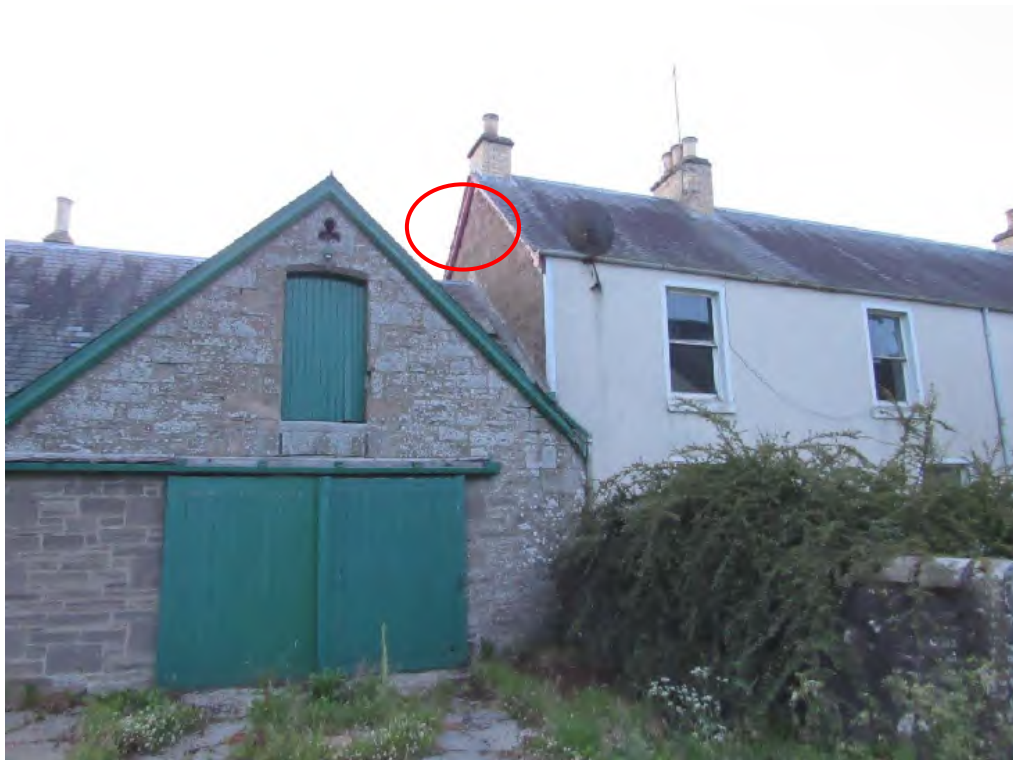
Figure 22. Exit point for brown long eared bats roosting within roof void D, shown in more detail in Figure 23.

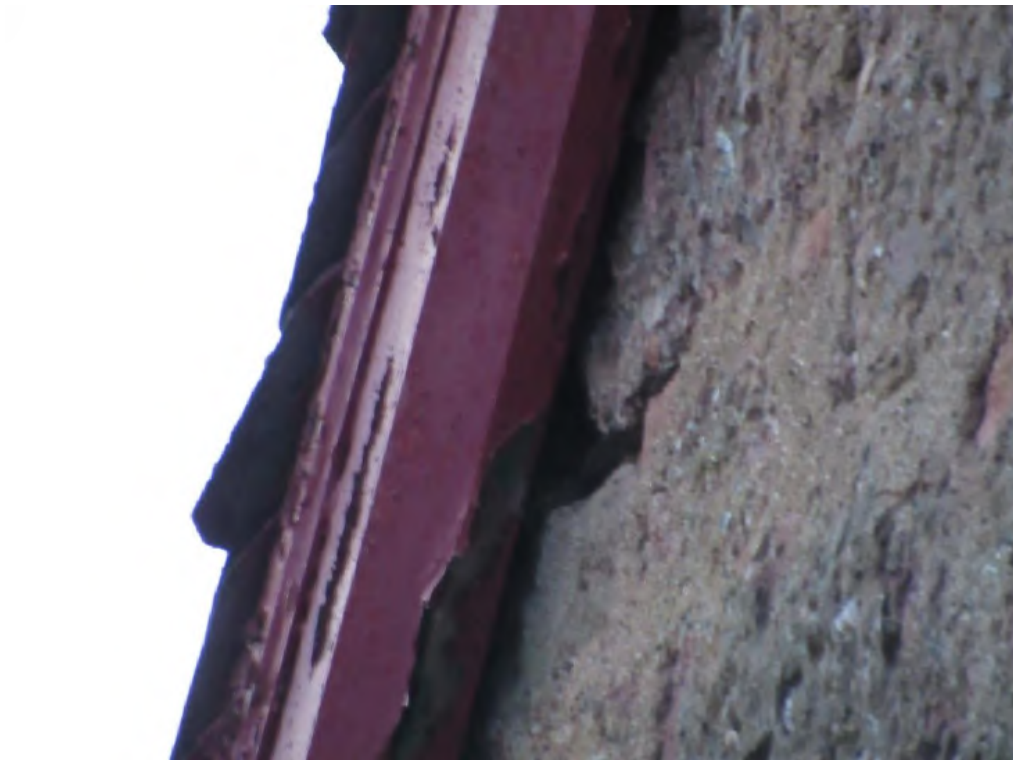
Figure 23. This small section of washed out mortar leads directly to roof void D and provides a potential exit/access point for bat species.

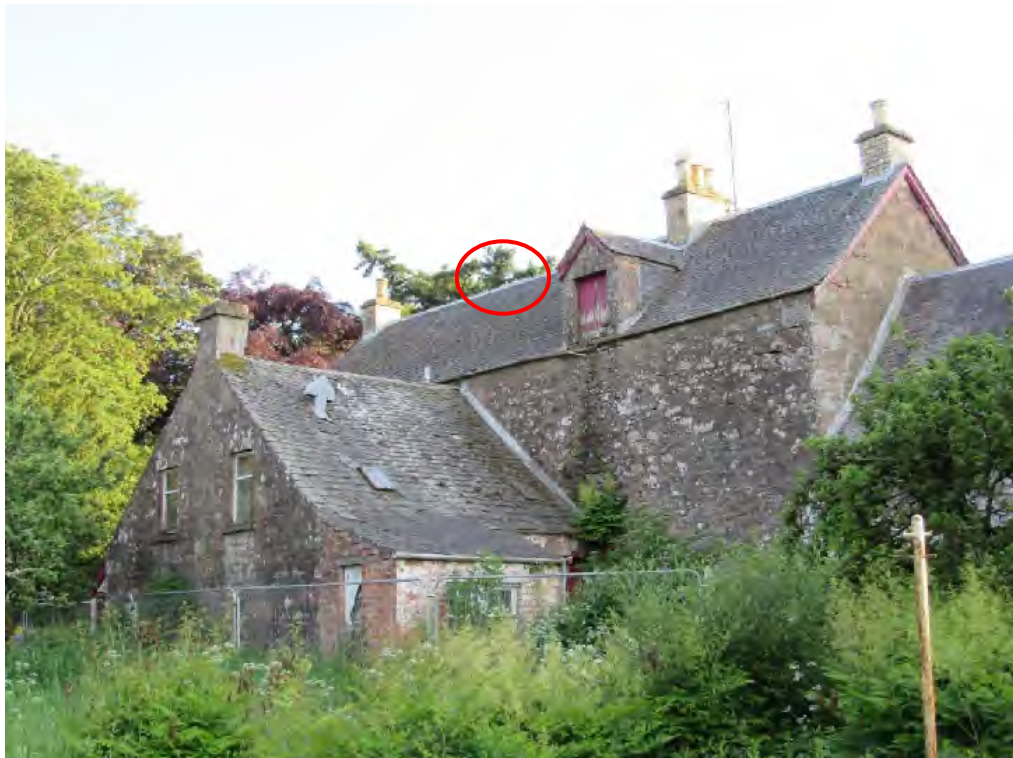
Figure 24. Soprano pipistrelle roost identified beneath the flashing on the eastern elevation of Wester Parkhead House, shown in more detail in Figure 25.

- 4.15. Bat activity was relatively high within the site with both common and soprano pipistrelles recorded foraging in good numbers above the overgrown garden to the immediate east of the farmhouse (it is estimated that no more than 6 soprano pipistrelles and 2 common pipistrelles were ever present). Brown long eared bats were also record foraging within the patch of mature woodland to the immediate south of the site. Brown long eared bats began swarming around the northern gable end of the house at 03:33 (see **Figures 22 & 23**) and by 03:51 all six bats had been observed entering the roof void via this location. The numbers of pipistrelle bats foraging within the site steadily diminished throughout the survey with bats observed commuting out of the site to the south and northeast. It is likely that the small patch of woodland to the south and east of the property provides an important foraging area for these bats in an otherwise agricultural landscape. However, only a solitary bat was recorded roosting within the property: at 04:03 a solitary soprano pipistrelle was observed entering the roost site identified beneath the flashing on the eastern elevation (**Figures 24 & 25**).

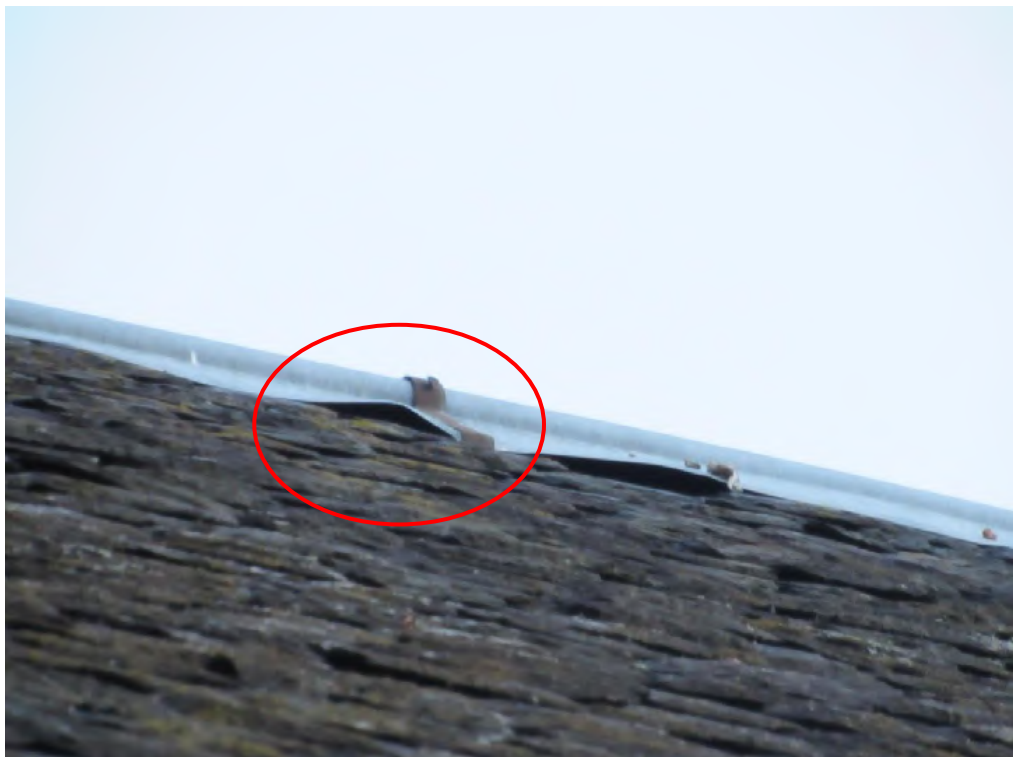
Figure 25. Only a solitary bat was ever recorded within the roost, see APPENDIX 2 for location.

(Shown in Figures 24 & 25)

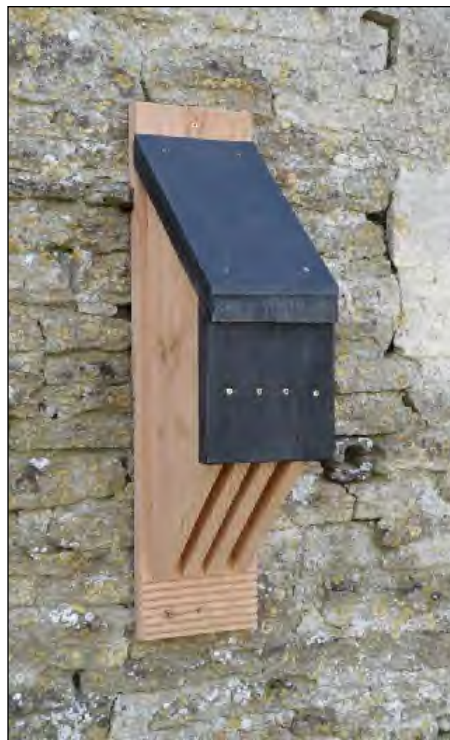
**Figure A4.1.** Vincent Pro bat box.
