| <b>TCP/11/16(581) – 18/01400/FLL – Alterations to roof at<br/>Wester Parkhead House, Parkhead Road, Blairgowrie</b> |

**TCP/11/16(581) – 18/01400/FLL – Alterations to roof at  
Wester Parkhead House, Parkhead Road, Blairgowrie**

# Re-roofing of Wester Parkhead Farmhouse, Blairgowrie

## Planning Supporting Statement

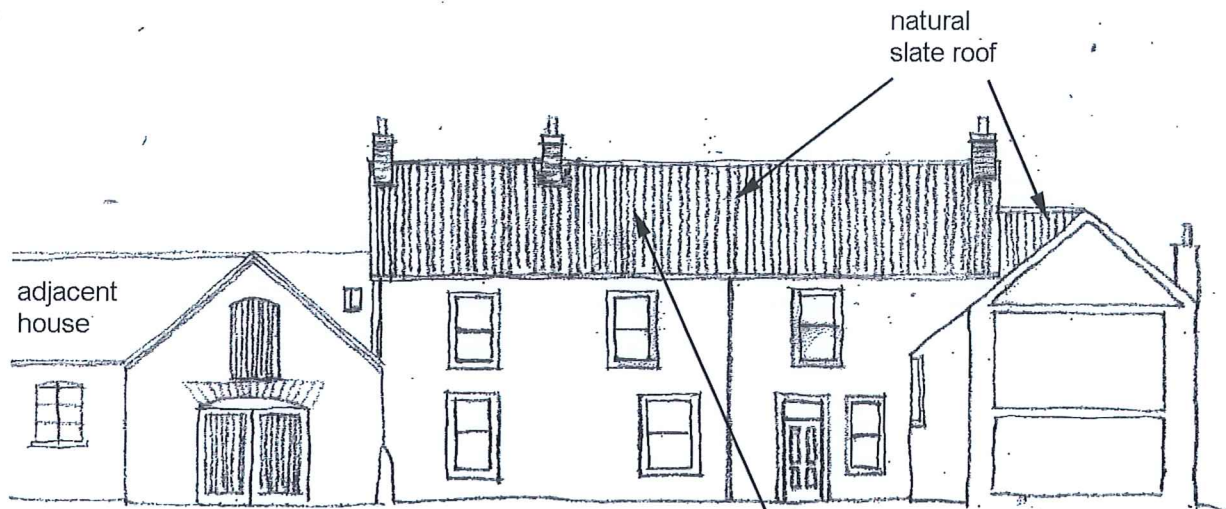
West elevation of East wing

It should be noted that the roof plan submitted indicates the entire roof structure is to be overclad with corrugated sheeting, however, the elevational drawing for the west elevation of the east wing indicates this to be natural slate. I sought clarification from the agent, however, at the time of writing this report no communication had been received. For the purposes of assessing the proposal, it is assumed the entire roof structure is to be overclad.
