**LRB-2024-23**

**23/00371/FLL – Erection of a holiday accommodation unit,  
ancillary shed and associated works, land at A'phairc  
Loisgte, Rannoch**

Re-submission of an application for the erection of a holiday accommodation unit which was refused 31 May 2022 under reference 22/00660/FLL.

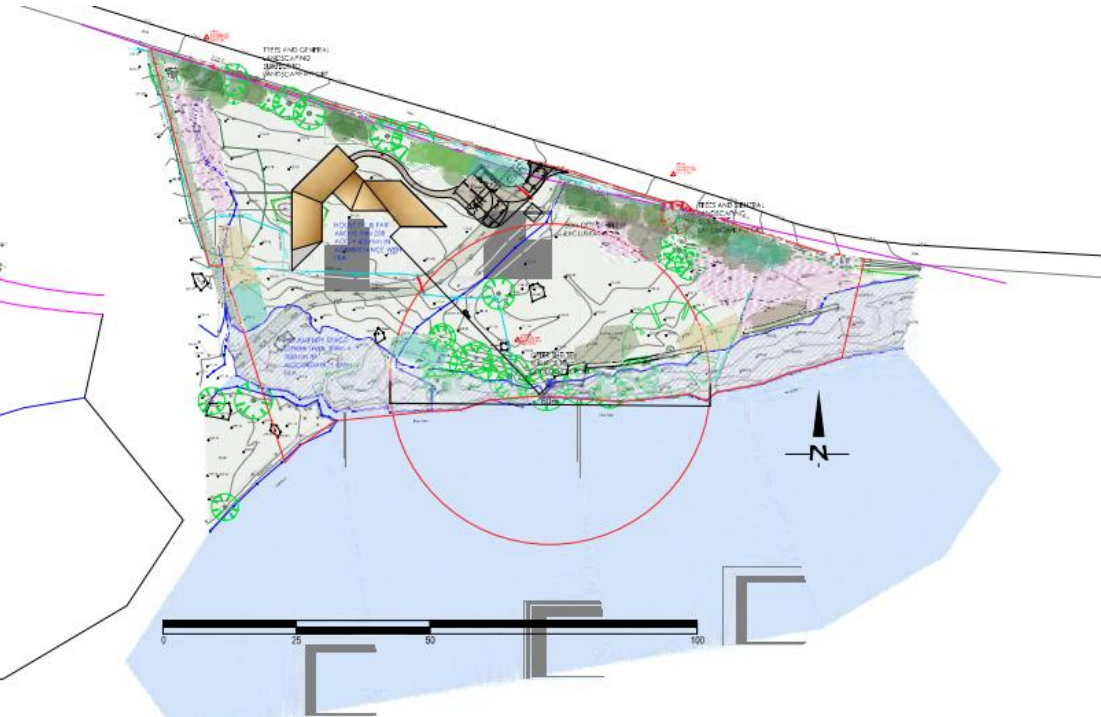
EXISTING BLOCK PLAN  
Scale 1:500

PROPOSED BLOCK PLAN  
Scale 1:500

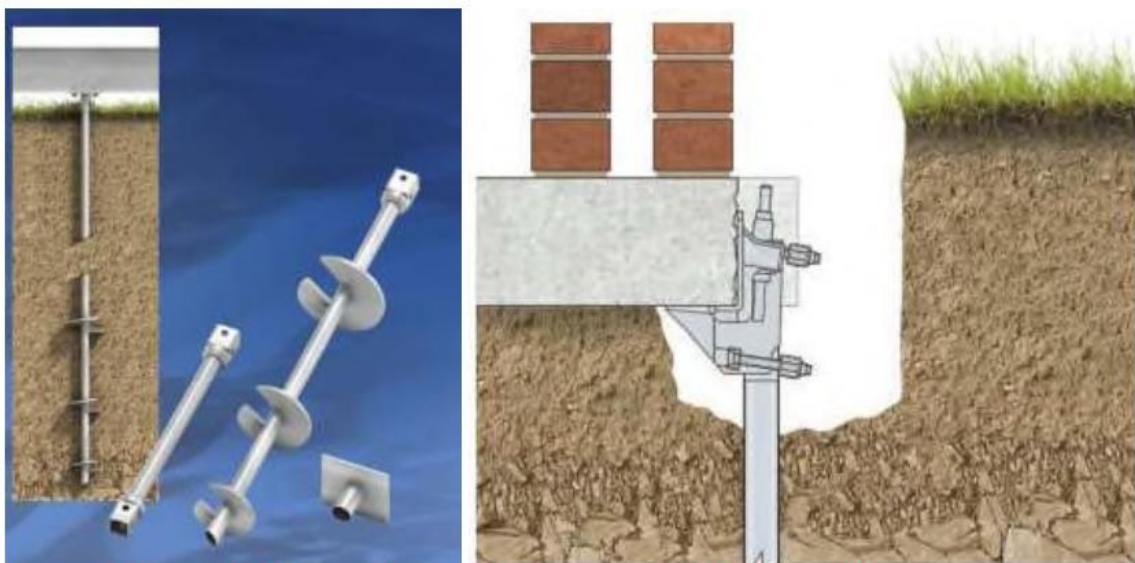
*Reference for Screw-piling foundation system for off-site modular construction*

Prior to this, screw-piles are fixed into the ground – this is the most minimally invasive technique for foundations – such would not affect any of the grassland or ecology of the site and allow wildlife to pass underneath the dwelling.

The other benefit of lifting the building off the ground is to preserve the current topography – the building will hover up to 1200mm in parts above the ground level.  
The building is not “of” the ground but is “off” the ground.

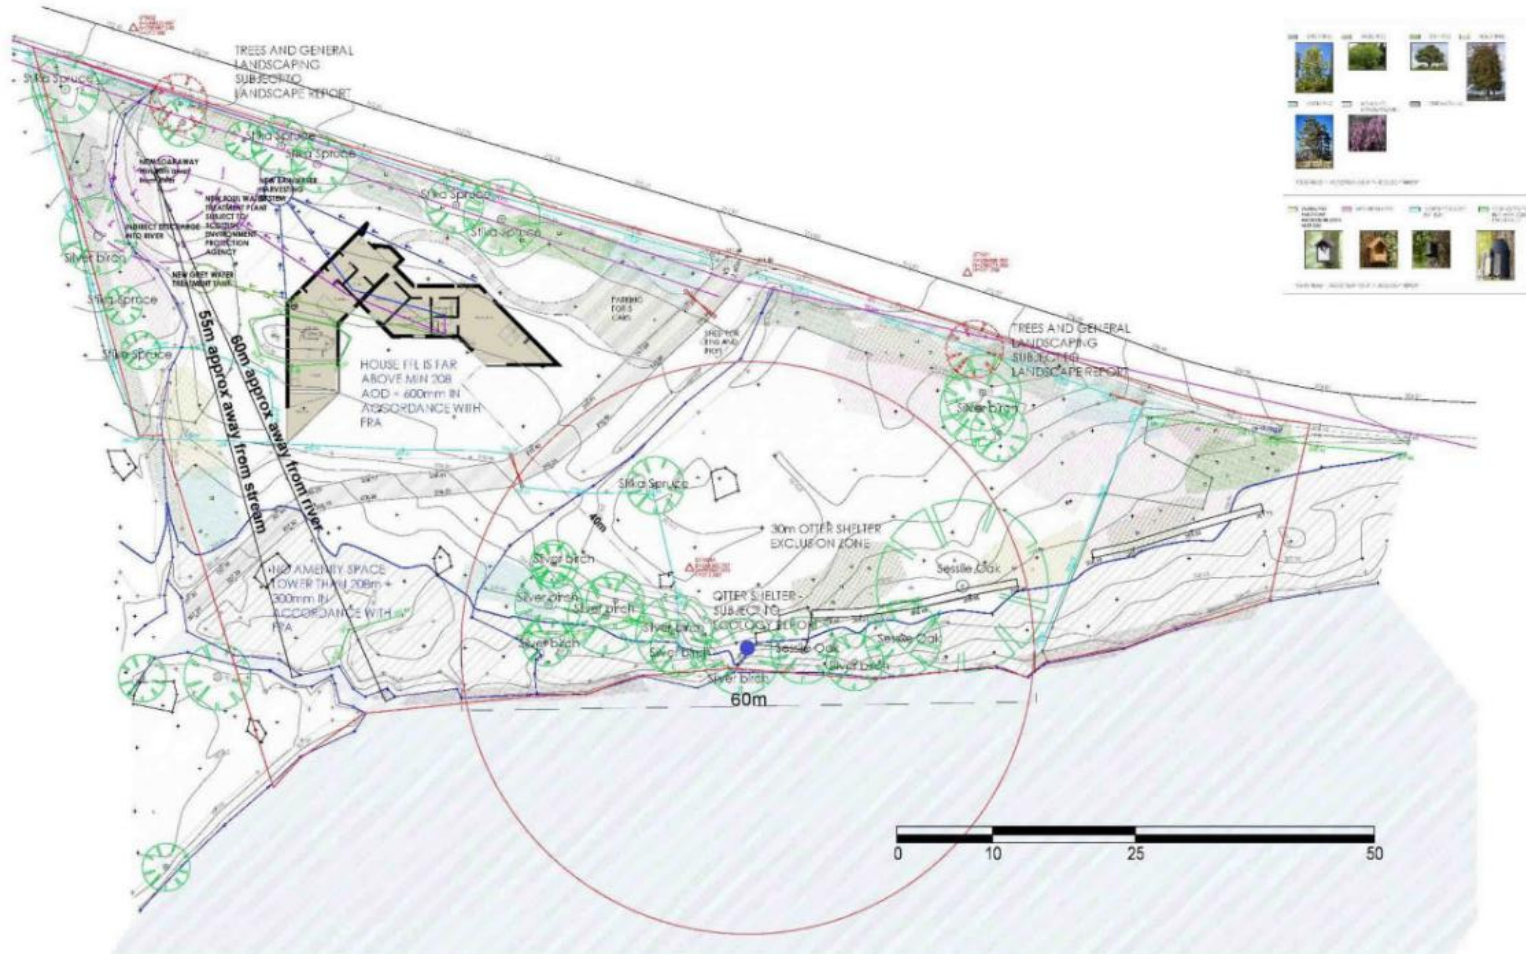
**Figure 4 Drainage and Landscaping Plan**

PROPOSED BLOCK PLAN - DRAINAGE  
Scale 1:200

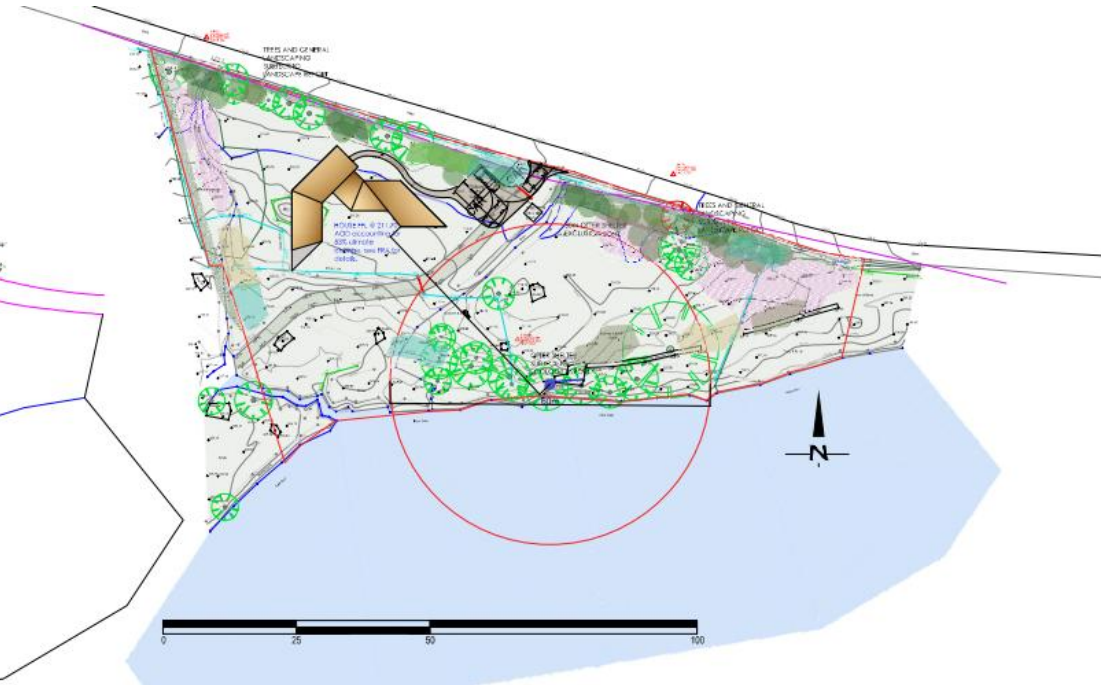
EXISTING BLOCK PLAN  
Scale 1:500

PROPOSED BLOCK PLAN  
Scale 1:500

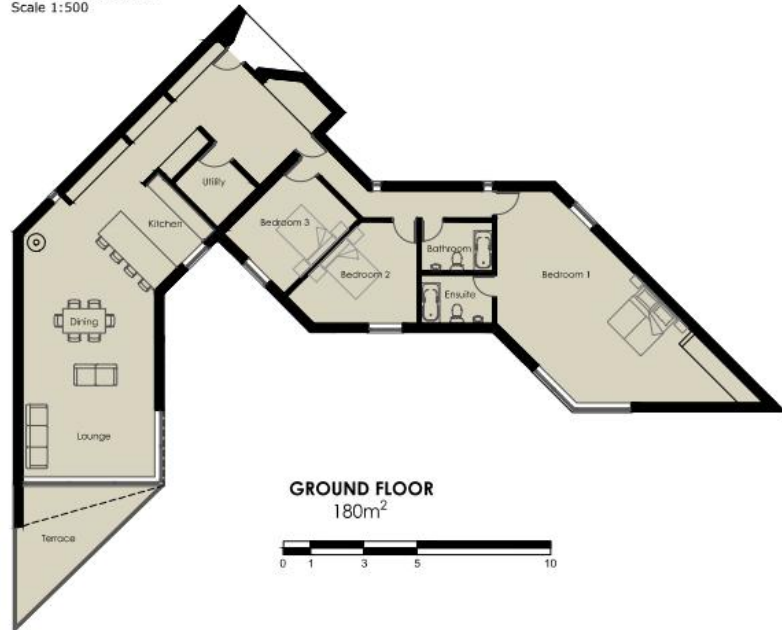
FLOOR PLAN  
Scale 1:100

GROUND FLOOR  
180m<sup>2</sup>
