## Dalginross 20mph Speed Limit Trial summary of results

## DALGINROSS

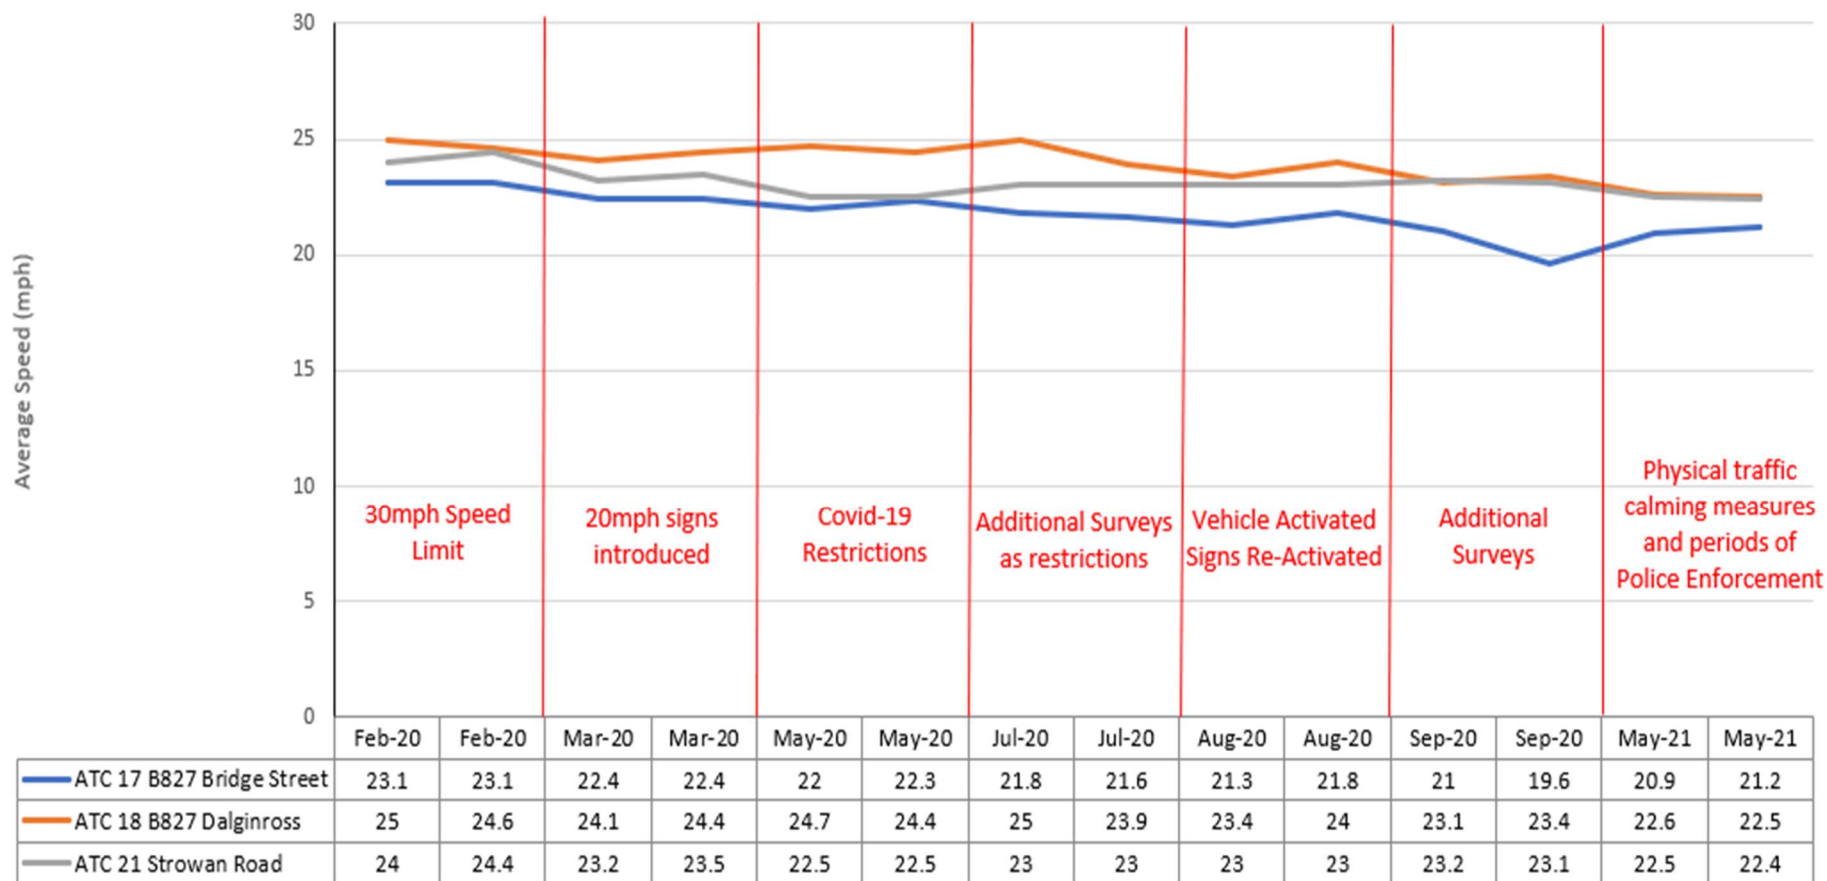
### Dalginross, Comrie

- 2.2 Three traffic counters were installed – south of Bridge Street, on the B867 Dalginross and on the residential Strowan Road. Vehicle-activated signs were located on Braco Road and South Crieff Road. The location map, speed tables and speed charts for Dalginross are contained in Appendix 2.

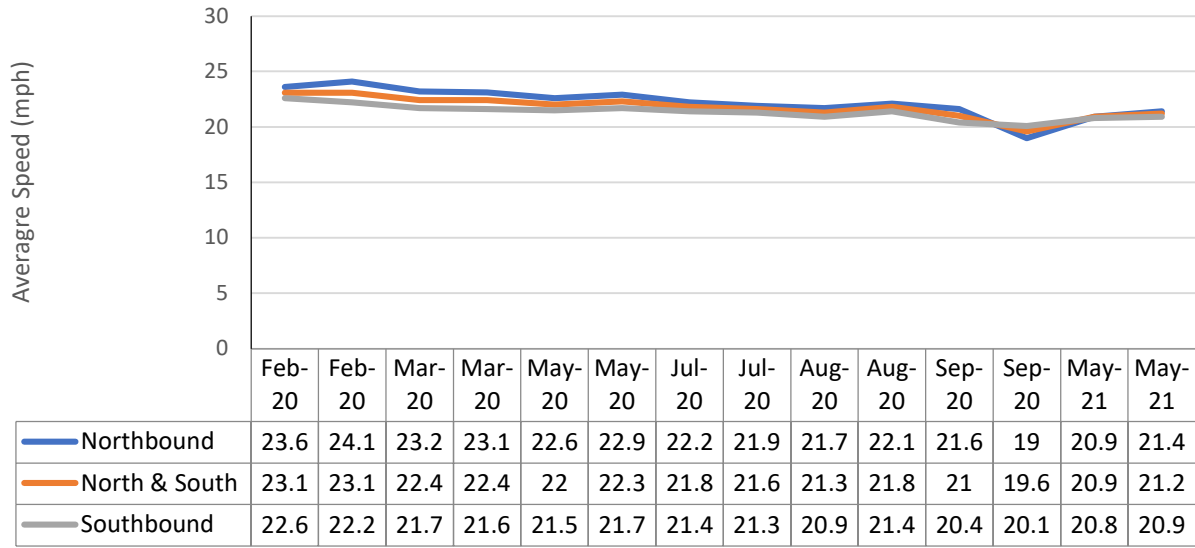
ATC 17 B827 Bridge Street

- 2.3 Before the trial, the average vehicle speed near Bridge Street was 23mph. There was a graduated drop of 1mph following the introduction of each of the traffic calming measures – signs, VAS, and speed cushions. However, the 85<sup>th</sup> percentile speeds remained around 28mph throughout the trial. Average and 85<sup>th</sup> percentile speeds were similar in both directions. Before the trial, 4% of vehicles were recorded travelling above 30mph. Again, there was a graduated reduction in vehicle speeds with the introduction of each change to the road environment. *Excessive speed data to be checked*
