PERTH AND KINROSS COUNCIL**Environment Committee****12 November 2014****Blairgowrie, Oakbank Road Landslip****Report by the Executive Director (Environment)****PURPOSE OF REPORT**

Landslip Options Report

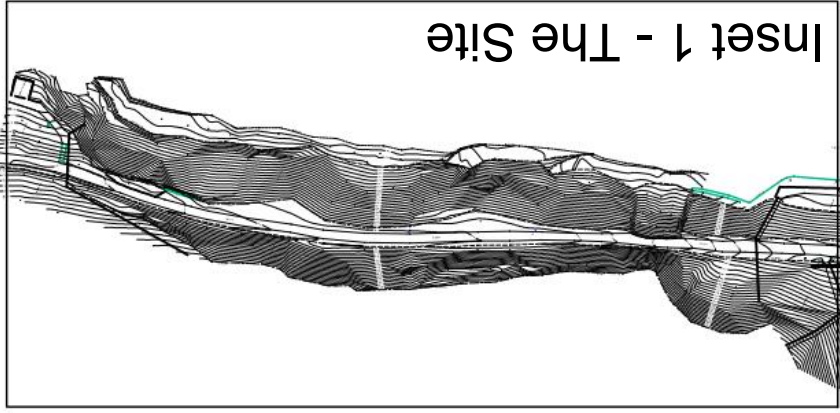
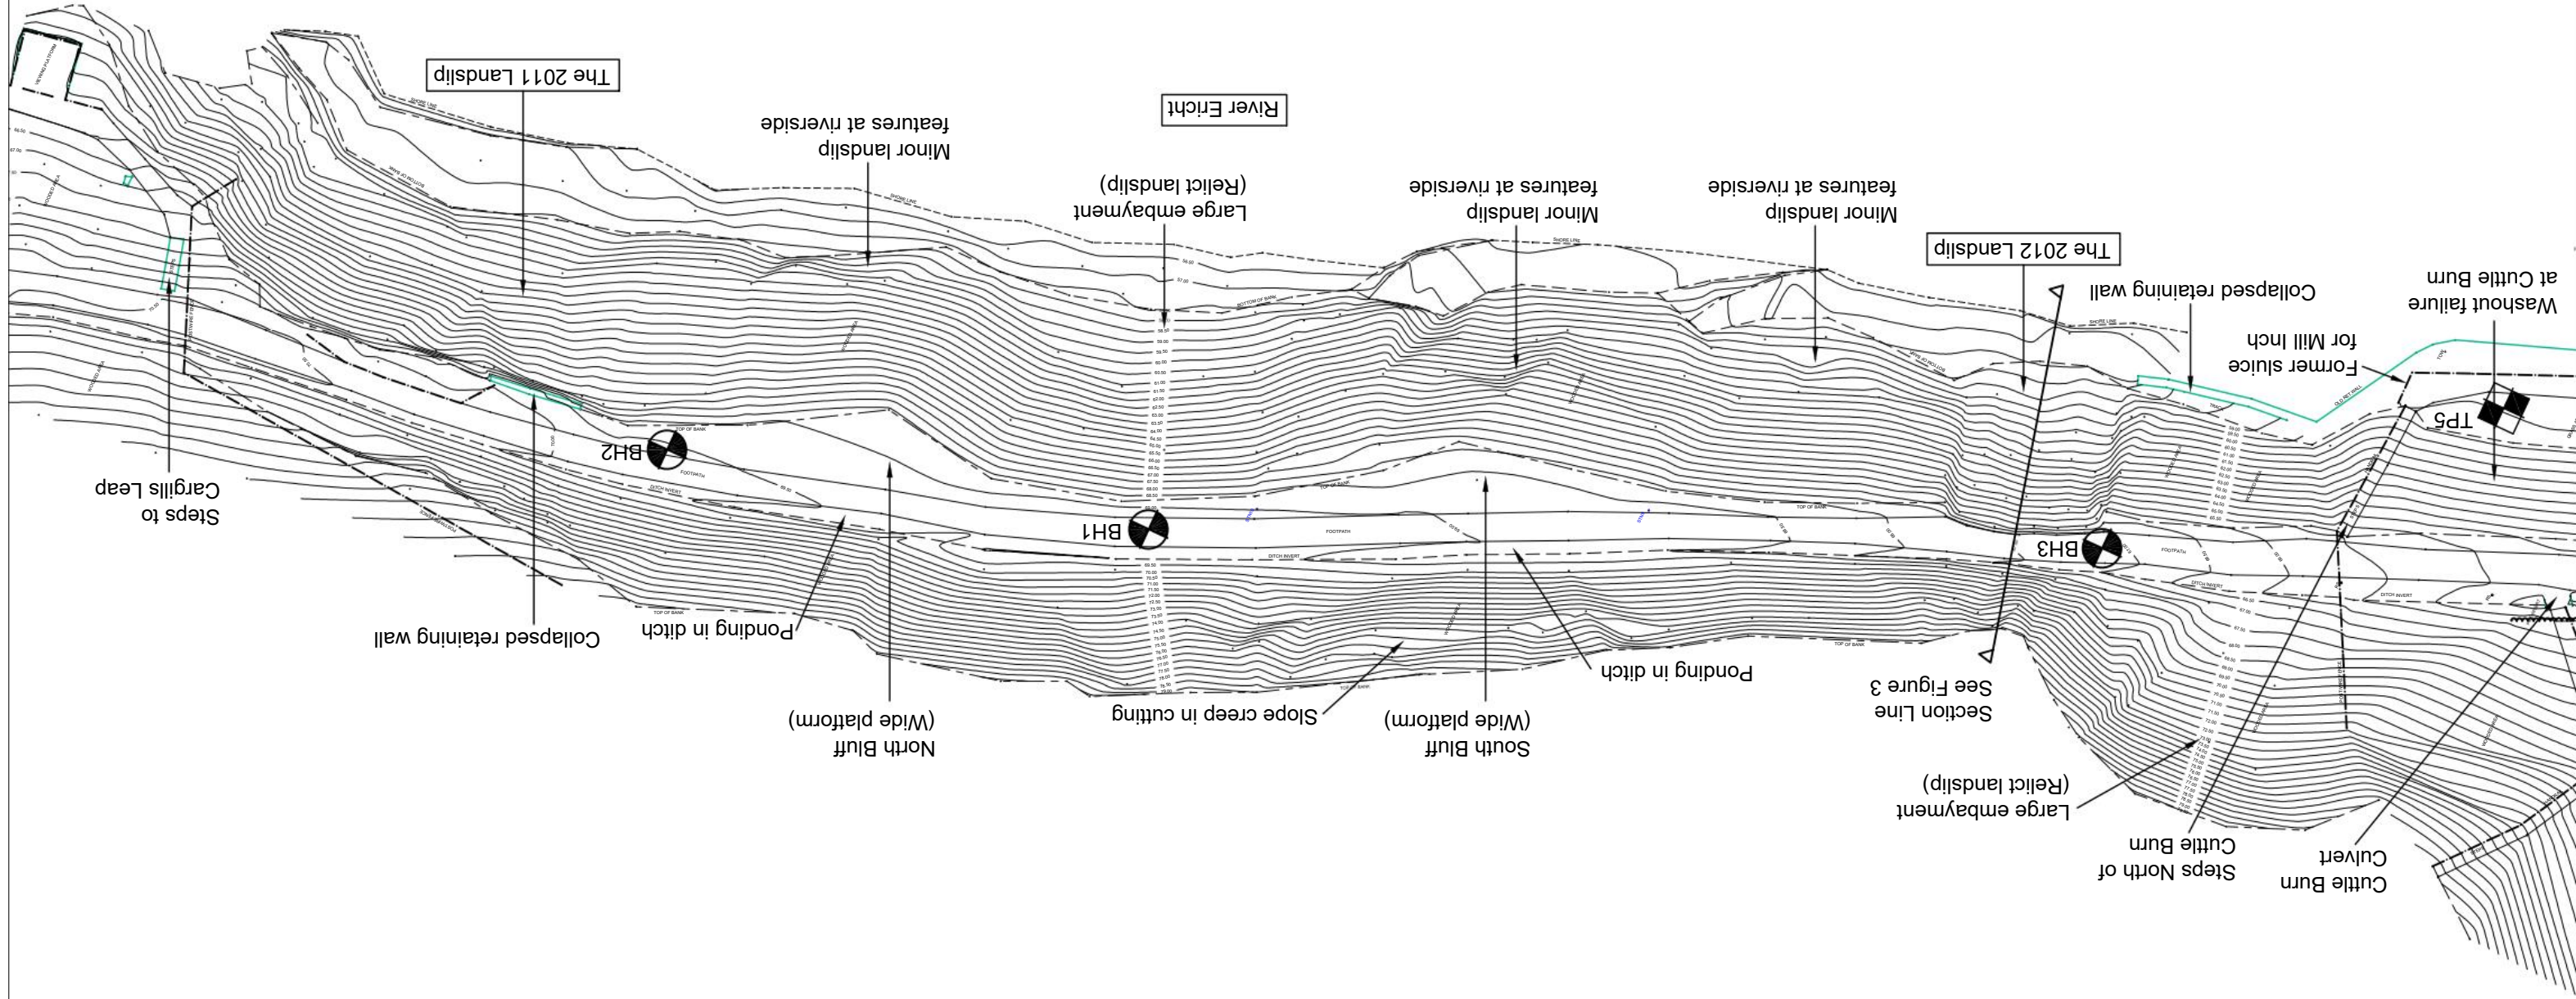
Figure 2 - Observed Landslip Features

Numerous areas of slope creep and landslip are evident on the steep flanks of this river terrace between Cargills Leap and Cuttle Burn. The main features are located on Figure 2 and these are summarised below:

The Slope between the two identified landslips can be characterised as two bluffs (north and south) and a large embayment between them (see Figure 2). The north bluff presents a relatively wide platform alongside the track and a heavily vegetated steep face directly above the river. The toe of this slope is over-steep due to erosion by the river and will have only marginal stability. The large embayment between the two bluffs also presents a heavily vegetated steep upper slope at 1 in 1.3 (37°), but this is offset from the river behind a lower slope of lesser gradient, being 1 in 2 (26°). It can be conjectured that this feature represents a relic landslip with debris removed by the river. Borehole 1 was located on the road to investigate ground conditions. The south bluff also presents a relatively wide platform alongside the track and a

Both of the above indicate the susceptibility of material to erosion and landslip on wetting up. Numerous areas of slope creep and landslip are also evident on the steep slopes above the road between Cargills Leap and Cuttle Burn. The main features are identified on Figure 2 and summarised below:

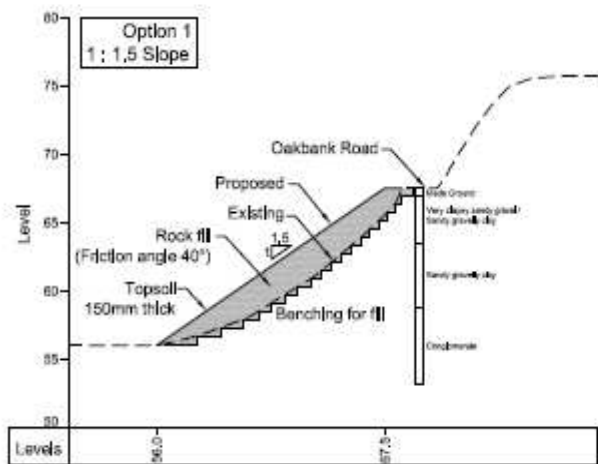
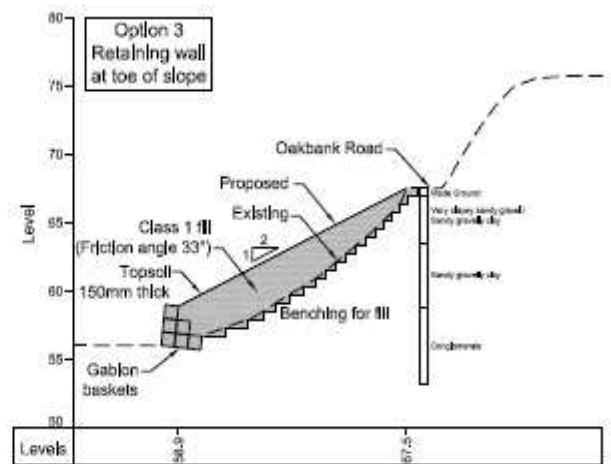
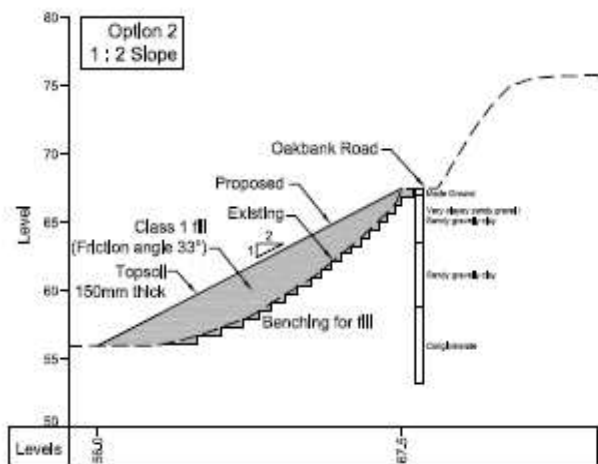
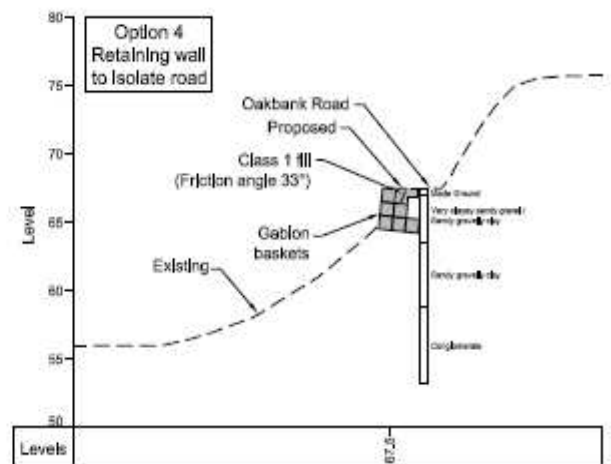
Stabilization Options

- Disadvantage: as for options 1, 2 & 3 and does not stabilise slope
- Cost: £200k for each landslip excluding accommodation works.

Option 4 - a retaining wall to isolate road, no fill
