**Proposed Stanley Community Hub, Perth Road, Stanley
For Stanley Development Trust**

**Preliminary Ecological Appraisal
Phase 1 Habitat, Protected Species Survey and
Ecological Impact Assessment**

Wednesday 31st May 2023

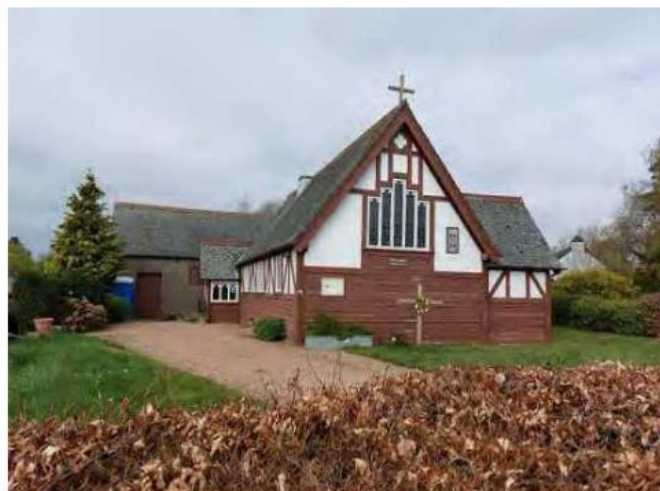
Figure 1: External Photo of the Episcopal Church with the Hall in the Background

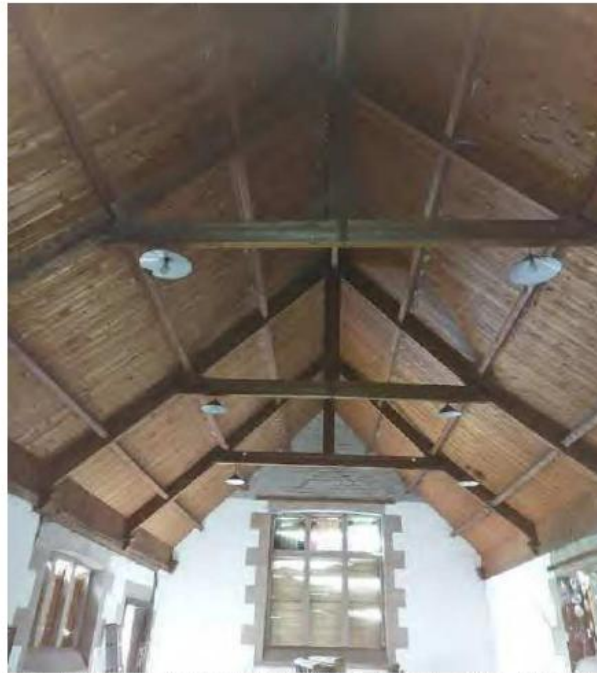
Figure 4: Site Photo Showing General Form of the Church Hall

The existing suspended timber floor has clearly failed in some areas and is extremely flexible throughout. It is likely that there is insufficient ventilation to the existing floor void and this has led to prolonged periods of high moisture content in the timbers, fungal infestation and decay.

As can be seen from figure 4, there is visible splaying of the roof A-frames out from the tie element and it appears that the A-frames are under designed for their current span and loading arrangement, or else have experienced decay similar to the floor joists and are starting to show signs of distress.

Overall, the structure is of poor quality and requires some extensive remedial works in order to extend it's useful life. The Suspended timber floor would need to be replaced with adequate ventilation, the existing masonry walls underpinned to provide suitable bearing for the foundations and to avoid seasonal effects, the walls repointed and partially rebuilt to address the movements and cracking that has occurred, and the roof would need to be fully assessed and likely strengthened to prevent lateral splaying.
