**Proposed Stanley Community Hub, Perth Road, Stanley
For Stanley Development Trust**

**Preliminary Ecological Appraisal
Phase 1 Habitat, Protected Species Survey and
Ecological Impact Assessment**

Wednesday 31st May 2023

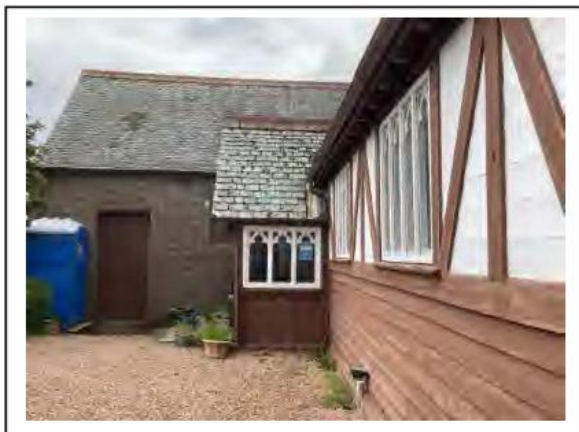
a. Church Hall North-East Elevation

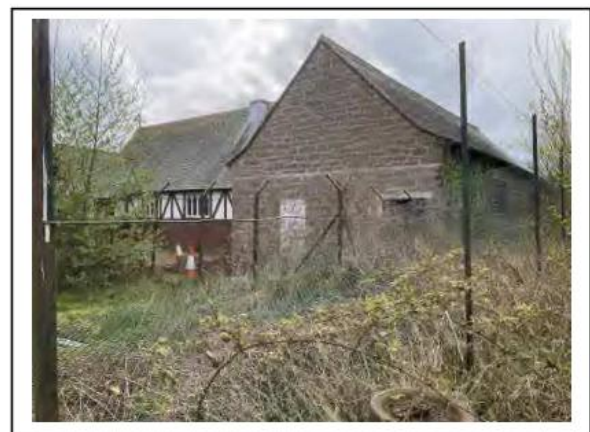
b. Church Hall North-West and South-West

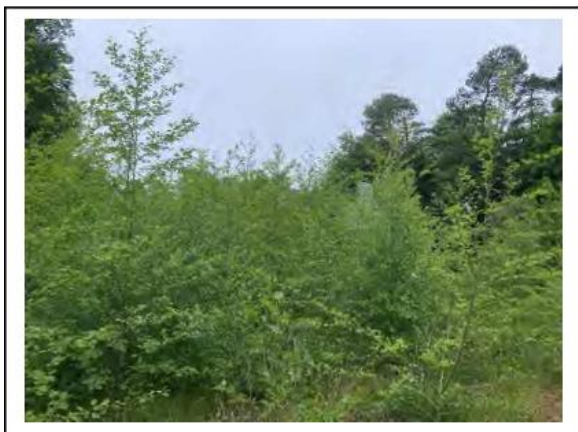
g. Natural regeneration in tennis courts

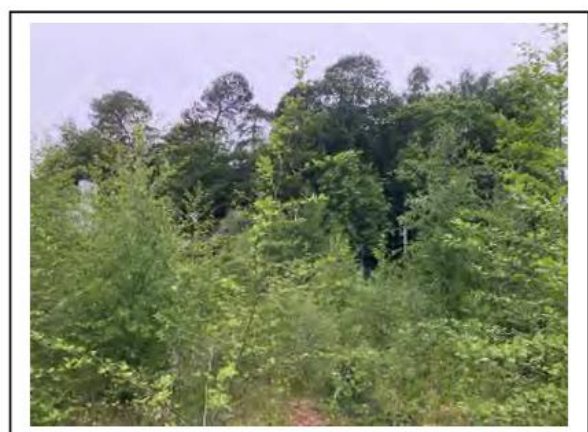
h. Natural regeneration in tennis courts
